ASSESSMENT OF HERITAGE IMPACT

Sydney Ports Corporation

PROPOSED INTERMODAL LOGISTICS CENTRE AT ENFIELD EUROPEAN HERITAGE ASSESSMENT

GRAHAM BROOKS AND ASSOCIATES ARCHITECTS AND HERITAGE CONSULTANTS

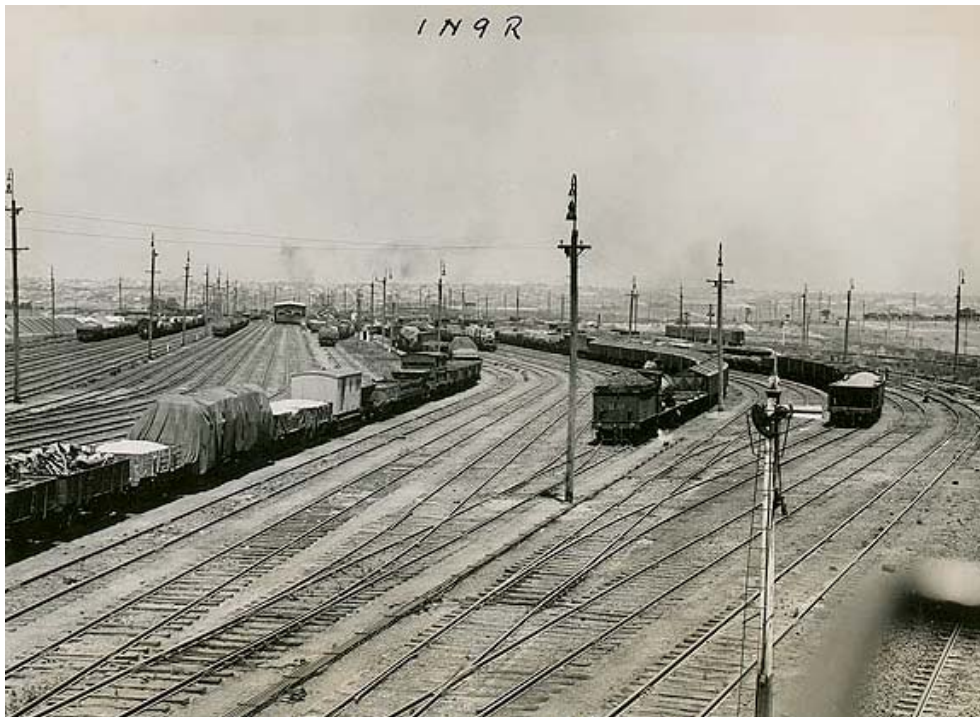
Figure 4. Former Enfield Marshalling Yard from the southeast when it was in operation. No date. State Records NSW. (Image no.12932-a012)

The former Enfield Marshalling Yard was first developed in 1916 following the NSW State Government's resumption of the Enfield Council's proposed "Enfield Park". See Figure 4 for an undated (but probably mid-20th century) photograph of the former Enfield Marshalling Yard.

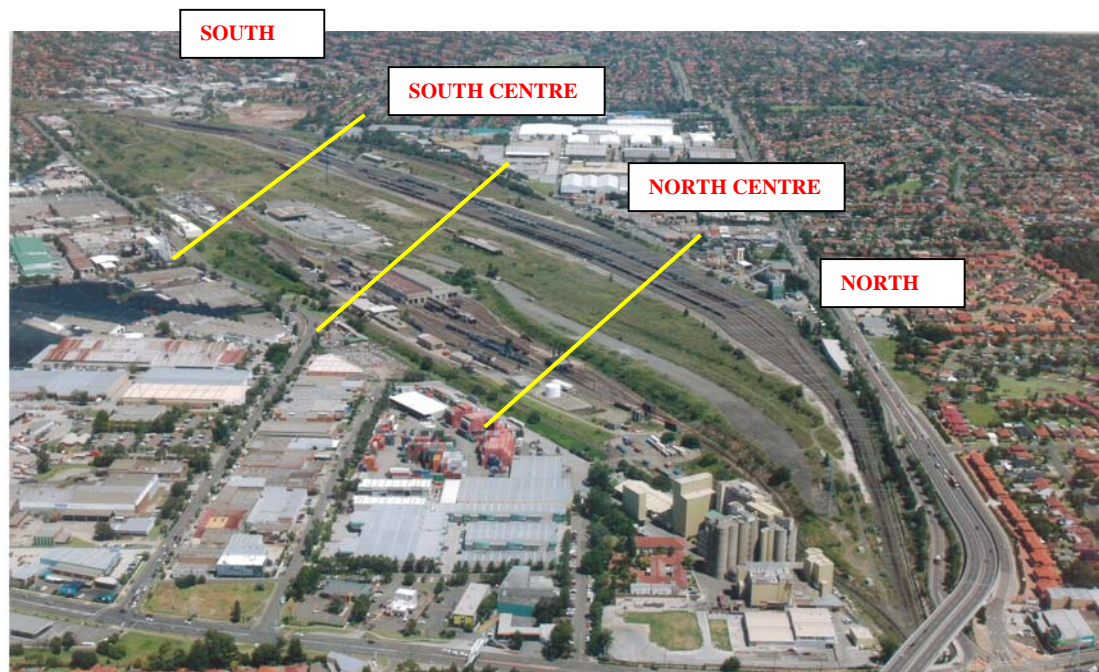
Figure 5. Aerial view of the former Enfield Marshalling Yard, Sydney Ports Corporation, 2001.

For the purposes of this heritage assessment, the former Enfield Marshalling Yard has been divided into four sections: North (adjacent to Roberts Road) (3.1), North Centre (3.2), South Centre (3.3) and South (3.4) sections.

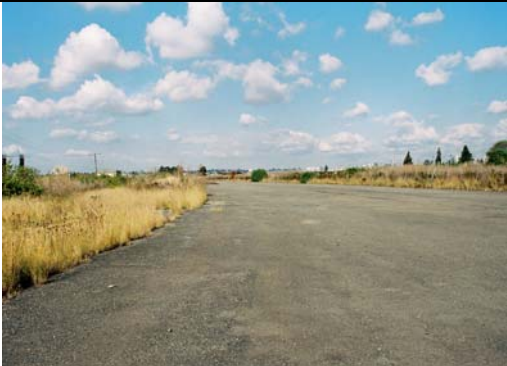
<p>Figure 8. View to the south showing the former location of the large coal stacking site and the marshalling sidings.</p> <p>This bitumen area, formally used for truck freight, is now some 3 to 5 metres above the original elevation of the former yards.</p>

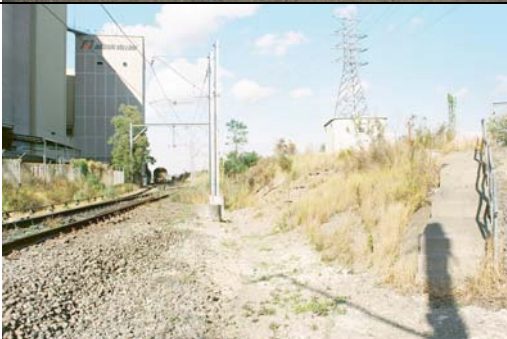
<p>Figure 9. View to the south showing the former UP Main Line.</p> <p>The steps show the build-up of fill in this area. When the yard was active, this area had a level elevation.</p>

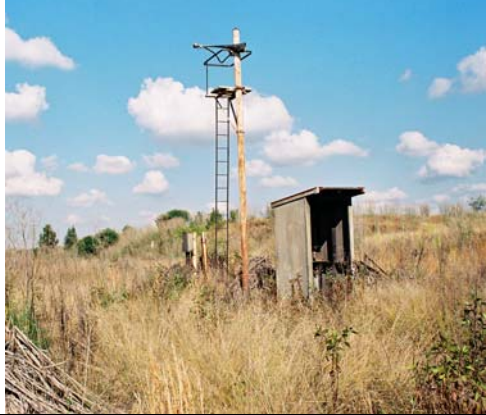
<p>Figure 19. The only surviving signal stanchion in the southeast sector of the former marshalling yard. Semaphore and signalling mechanism has been removed.</p>

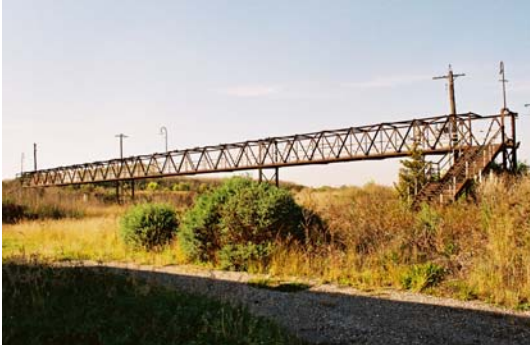
<p>Figure 22. The second-generation pedestrian bridge on the site. An earlier pedestrian bridge near the former Roundhouses No. 2 and No.3 has been demolished.</p>

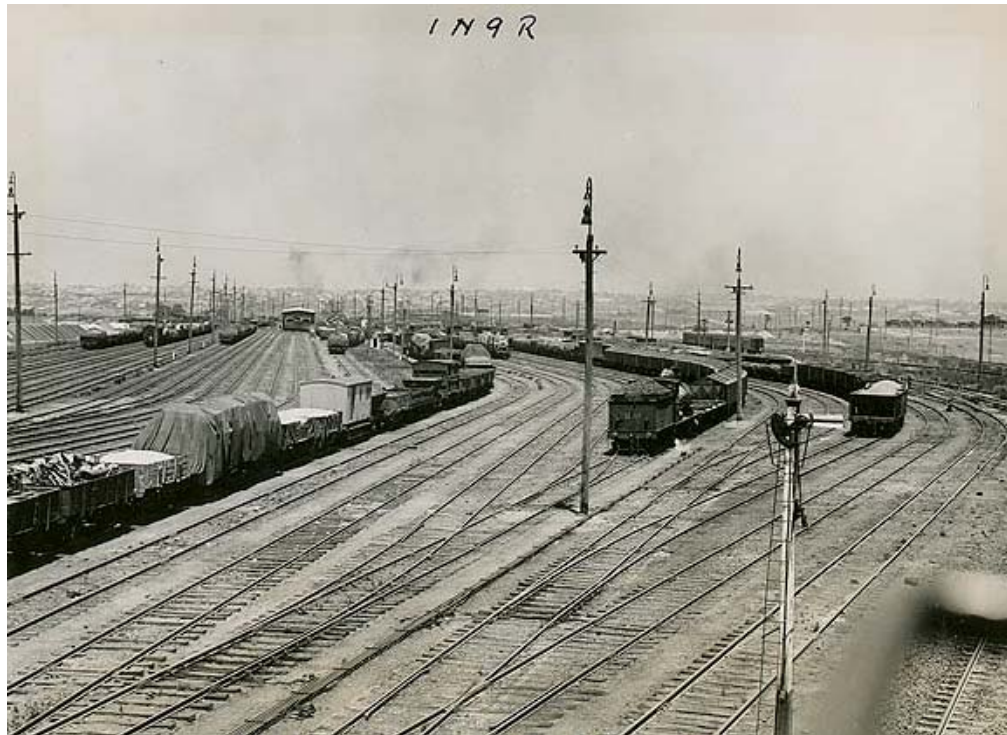
Figure 28. Former Enfield Marshalling Yard from the southeast when it was in operation. No date. (Mid-20th century) State Records NSW. (Image no.12932-aO12)

These photographs show a "before and after" comparison of the transformation of the former Enfield Marshalling Yard to a derelict landscape that no longer has any resemblance to its former use.

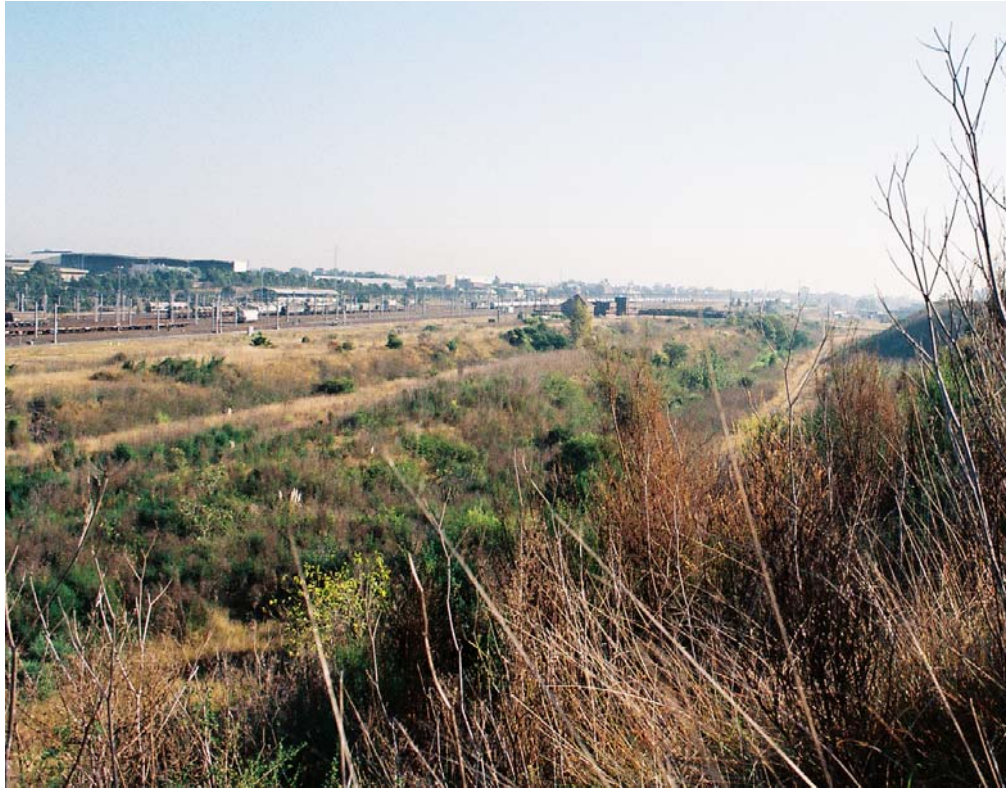
Figure 29. Former Enfield Marshalling Yard from the southeast. June 2005.

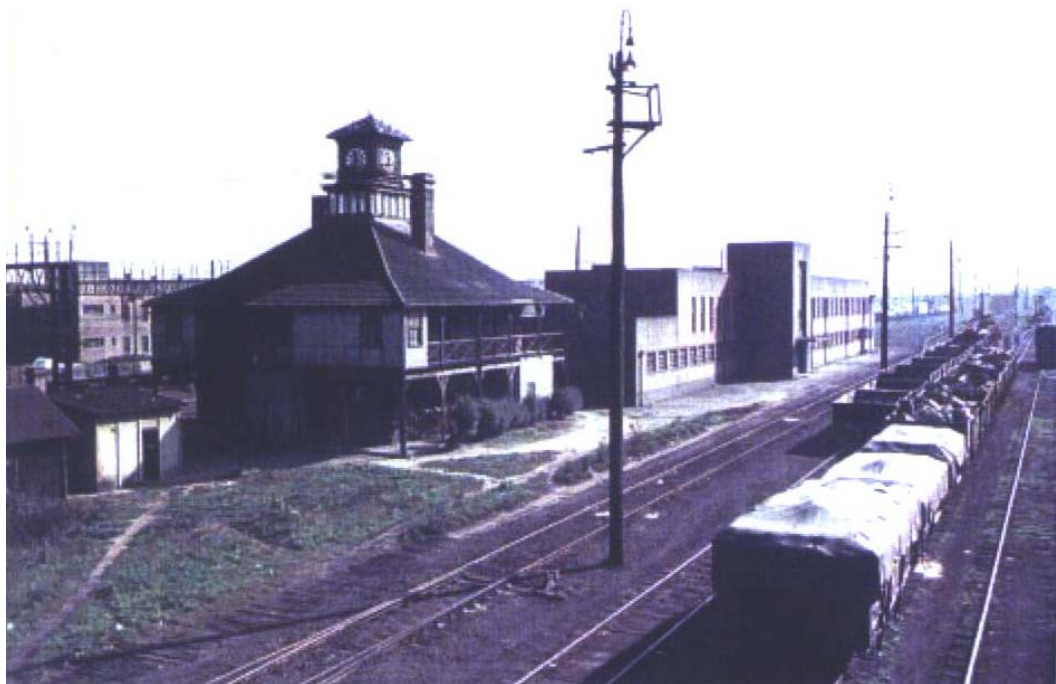
Figure 34. The Yard Master's Office from the pedestrian bridge, 1964. Photo by Alex Grunbach from John Oakes, Sydney's Forgotten Goods Railways, Australian Rail Historical Society, 2001.

The original structure was fitted with a rooftop observation platform that was reached via a surviving internal timber stair. This observation platform, a later clock (see Figure 34) and the two original chimneys have been removed and a late 20th century re-roofing with tiles has radically altered the roof plan.

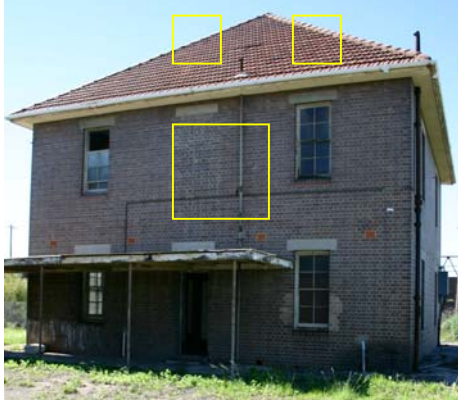
<p>North side. Upper balcony/ verandah missing, window bricked in on upper level. Chimneys have been removed.</p>

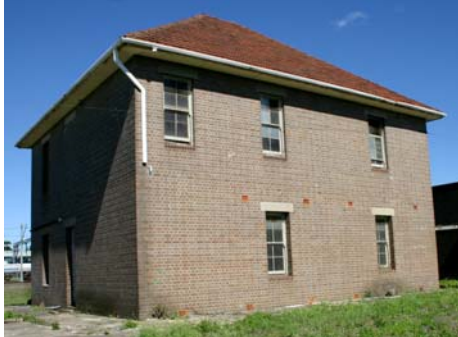
<p>East elevation. Upper balcony/ verandah missing. Original window placement intact. Note that there is no window to ground level stairwell but a window is provided on level one.</p>

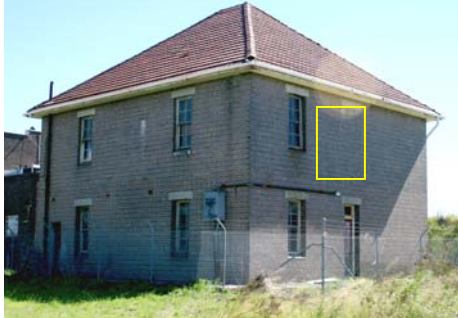
<p>South-western corner. Door onto balcony missing. Note that there is no window to the level one stairwell on this elevation.</p>

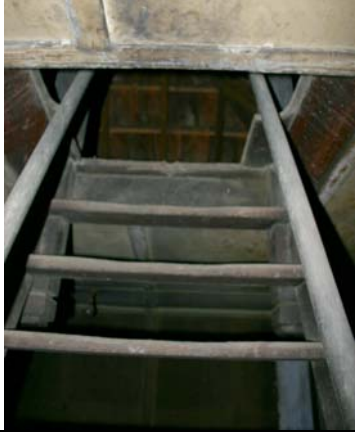
<p>Internal stair to attic. Former approach to observation area and clock, now demolished.</p>

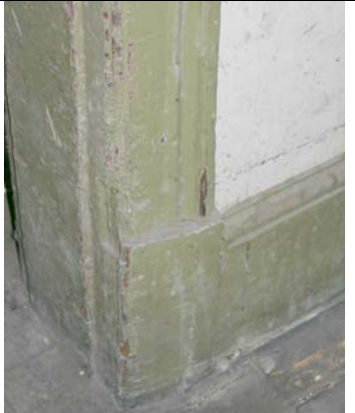
<p>Timber skirtings and door mouldings pattern ground floor hallway.</p>

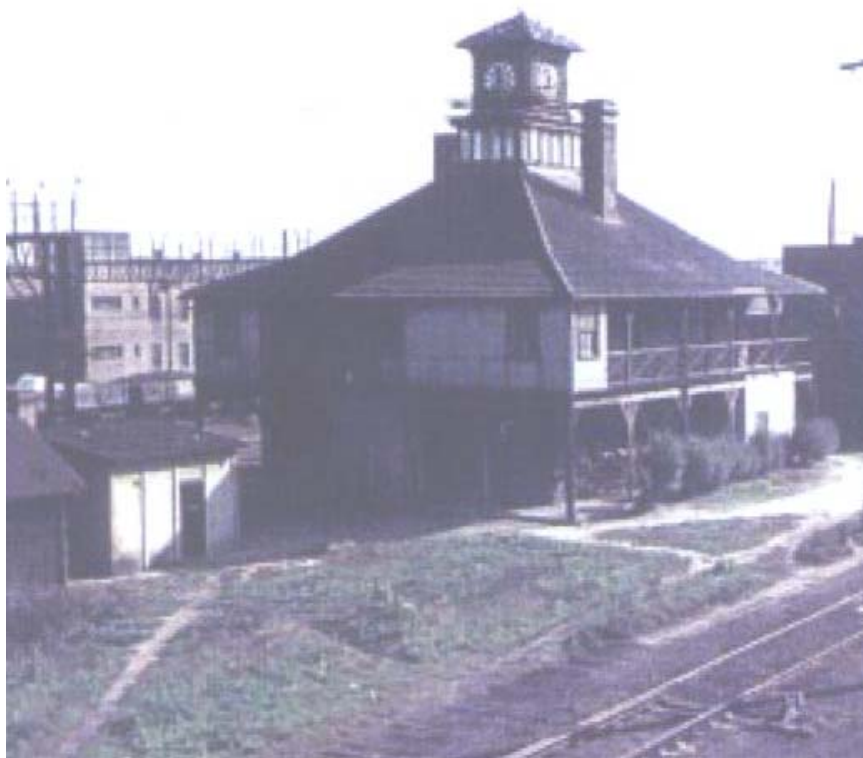
Figure 37. Yard Master's Office, 1964. Alex Grunbach, Australian Rail Historical Society in John Oakes. Sydney's Forgotten Goods Railways, Australian Rail Historical Society, 2001.

Some time before 1967, a substantial tower (est. 7 metres) appeared with the lookout (now enclosed) and topped by a clock. As shown in Figure 37, the roof of the Yard Master's Office appears to be tiled with a break in the fall of the roof where it meets the verandah section. In the 1967 image in Figure 37, substantial sections of the verandah are enclosed with fibrous cement sheet. A site visit in 2005 revealed that all elements of the verandah, tower and clocks have been removed.

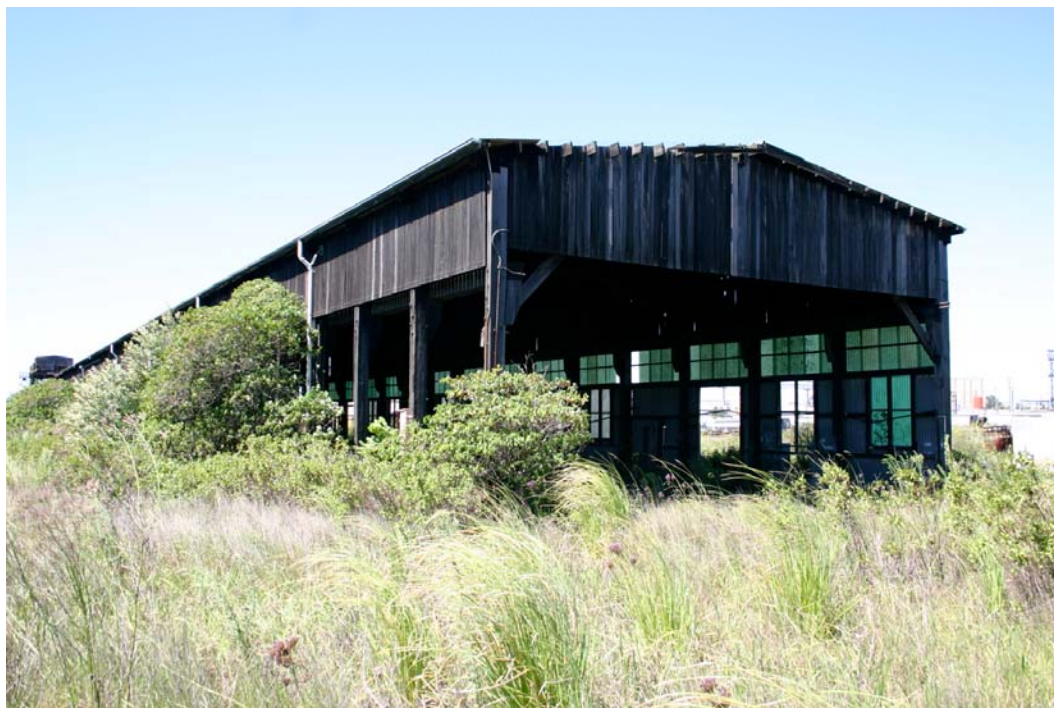
Figure 38. Former Transhipment Shed & Wagon Repair Workshop. Northern elevation. January 2005.

Earlier reports on the former Enfield Marshalling Yard identify the wagon repair workshop as a building of the 1920s. However, the structure is clearly identified on an Australian Railway Historical Society Resource Centre yard diagram of 1927 as an 86-feet long (26 metres) original "Transhipment Shed". It is the view of Graham Brooks and Associates that the current building is the Transhipment shed, later extended and/or adapted for a workshop. The shed now measures approximately 90 metres in length.

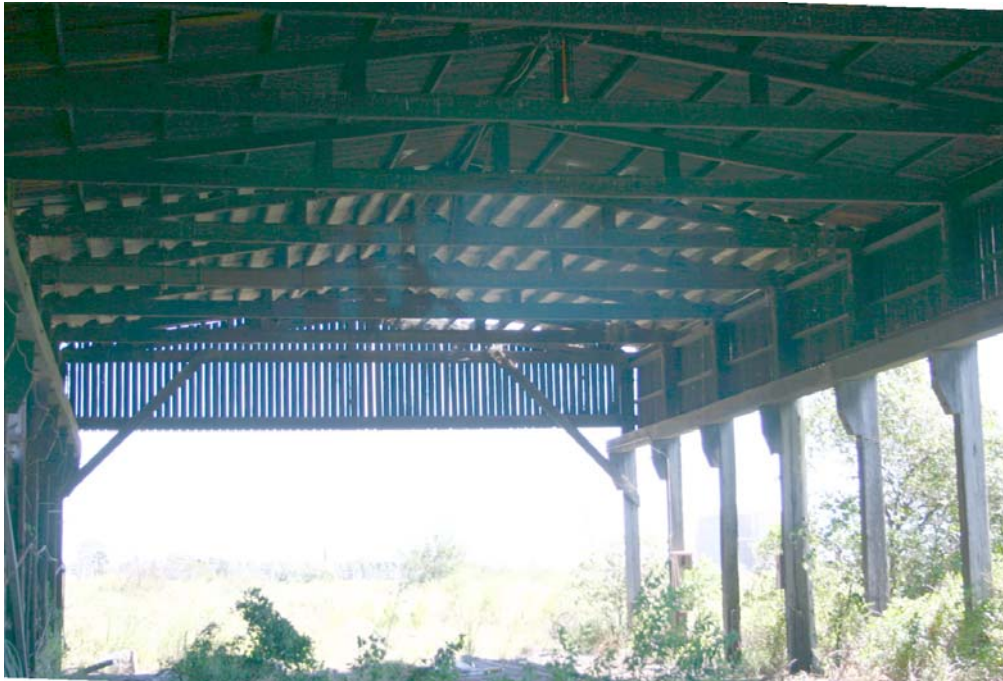
Figure 39. The internal structure of the Transhipment shed & wagon repair workshop showing the palings enclosing the gable ends and the bolted braced frame construction.

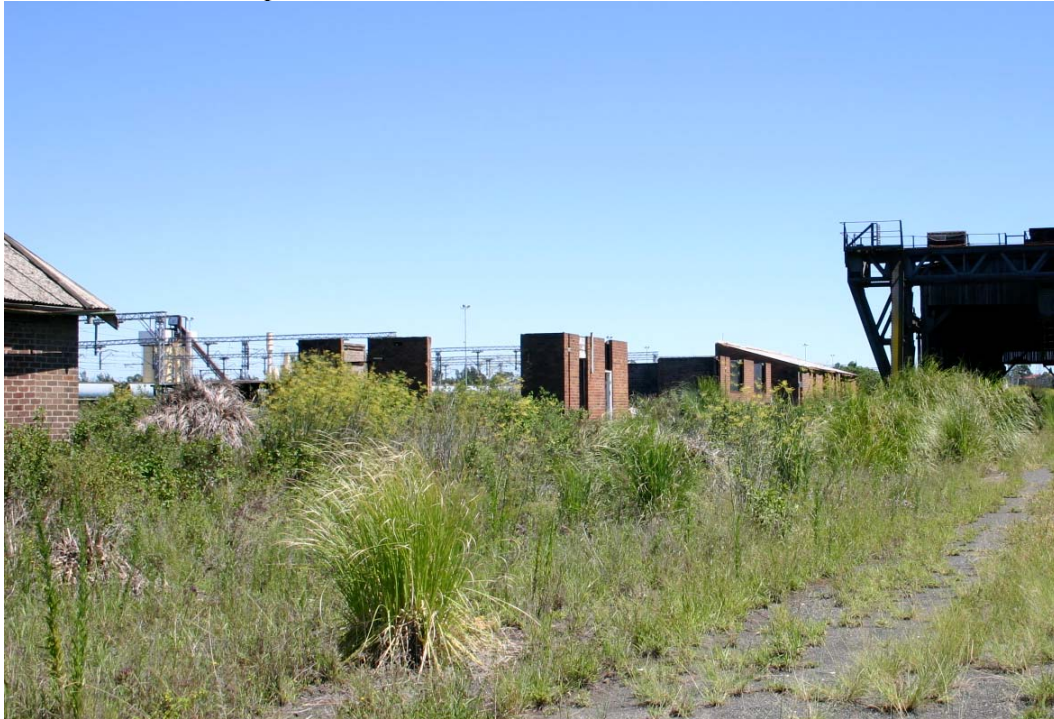
Figure 40. The ruins of the administration buildings associated with the later wagon workshop. January 2005.

A grouping of brick buildings, now in ruins, lies to the southwest of the workshop and may have supplied administrative support and specialised trades for the later workshop activities. These support buildings are not identified on plans from the 1920s that show the transhipment shed. These supportive buildings occupy the approximate position of the "repair siding" to the west of the transhipment shed.

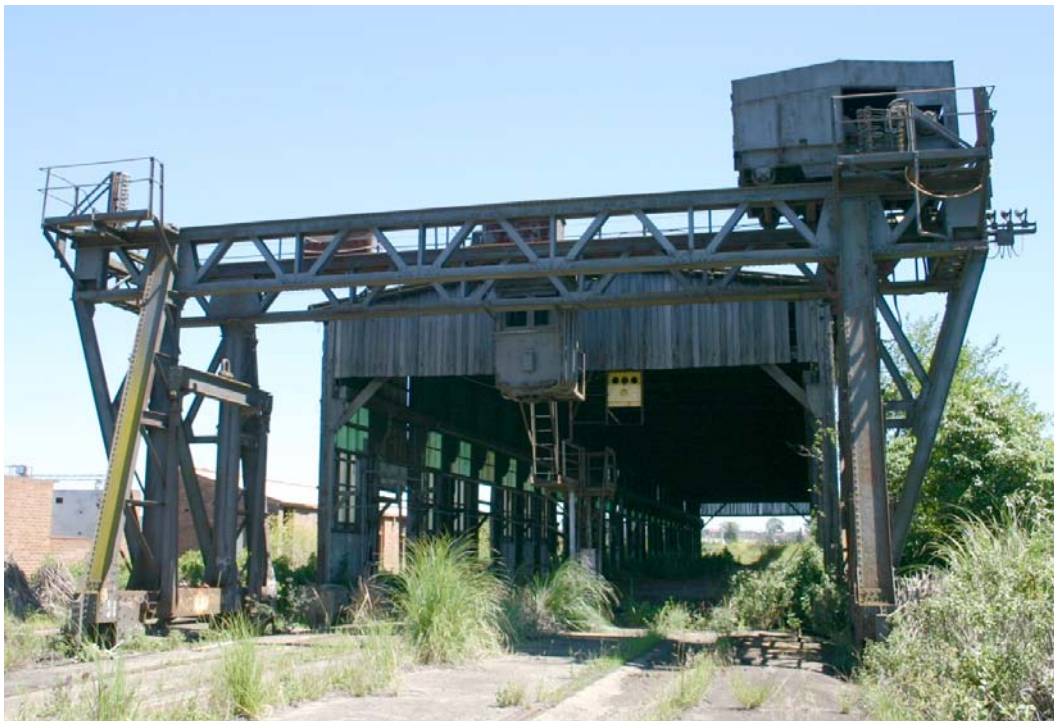
Figure 41. Mid-20th century electric-powered gantry crane outside of the Transhipment shed & wagon repair workshop. January 2005

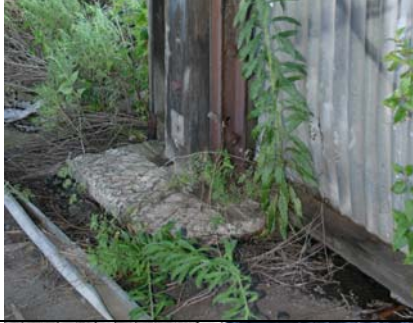
<p>While the timber posts of the shed have been placed in concrete, termites have gained access through the base of the posts.</p>

3) Transshipment shed and wagon repair workshop	Local Significance. Recommend recording and re-siting of sound fabric to rail heritage organisation, if not wanted, recycle into amenities within Intermodal Logistics Centre. If not required, record and demolish.	A significant number of timber columns are damaged by terrestrial termites. Unstable. ²

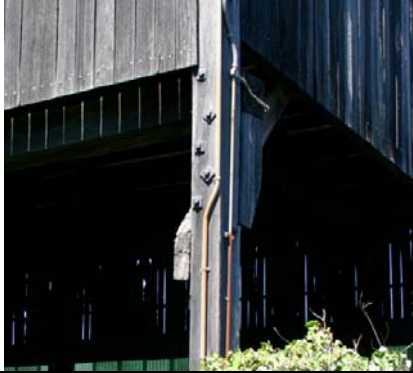
<p>Iron bolts support the braced frame construction (east side).</p>

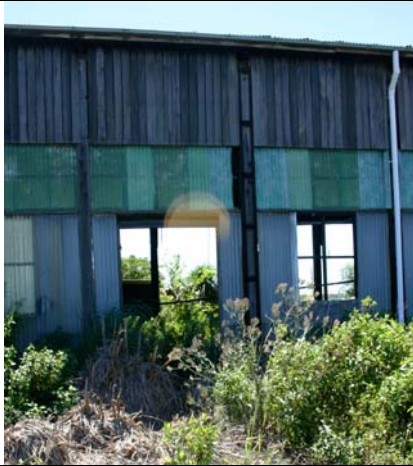
<p>The western side of the Transshipment shed was enclosed ca. 1946 with contemporary materials including transparent fibreglass corrugated sheeting.¹⁰</p>

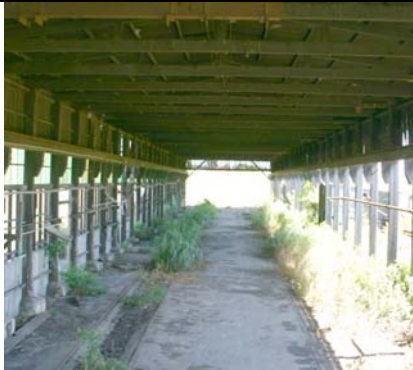
<p>Internal view of the Transshipment shed to the north showing open and closed sides and probable position of dual tracks into shed. The width of the track placement would allow the use of a platform for transshipping.</p>

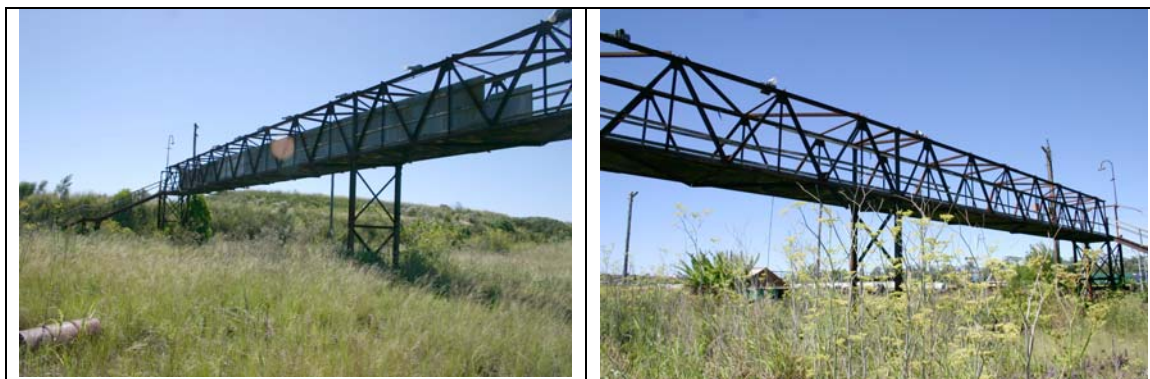
Figure 43. East (right) and west (left) terminations of the pedestrian bridge, January 2005.

The pedestrian bridge is a steel Warren Truss structure with a reinforced concrete deck resting on two sets of braced pylons. Based on a drawing reproduced by R.E. Best, the pedestrian footbridge was constructed in 1937.¹³ This is consistent with the findings of engineering historian Don Fraser in his *Survey of Railway Footbridges* of 1996 that found footbridges of this type constructed in 1929 and 1944.¹⁴

Fraser notes, "An important feature of the Enfield F/B [footbridge] is its height, tall enough to have cross-bracing above the deck. Pedestrians walk through a "spatial tunnel" and such bridges, road, rail or other use, are called "through" bridges."¹⁵

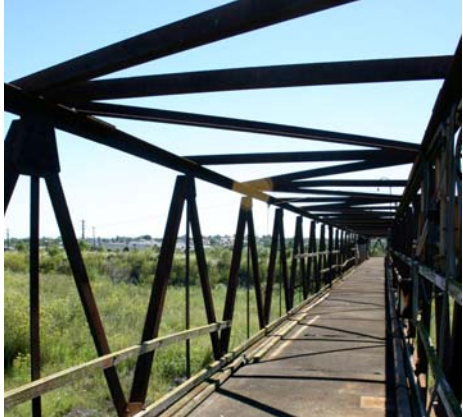
<p>Reinforced concrete decking on pedestrian bridge. This view illustrates the "through" bridge quality of this structure.</p>

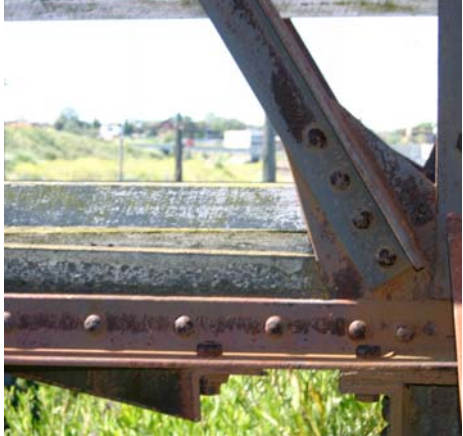
<p>Detail of rivets and bolt fasteners for the truss.</p>

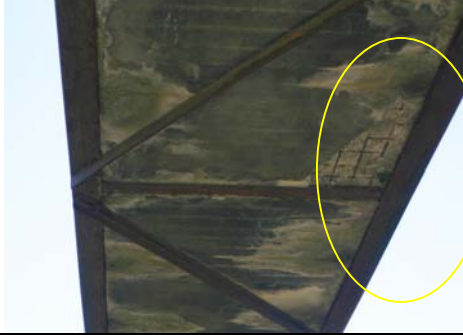
<p>Underside of the pedestrian bridge showing the bracing supporting the concrete deck. Spalling (yellow) is evident from the corrosion expansion of reinforcing rods.</p>

ITEM	GBA ASSESSMENT	HYDER ENGINEERING ISSUES
1) Pedestrian footbridge (Workmen's footbridge)	Local Significance. Recommend recording and re-siting to rail heritage organisation. Retain an element on-site if possible	Concrete walkway and stair tread not reclaimable. Timber handrails lost. Remainder of structure can be disassembled. Remedial work required for re-use.

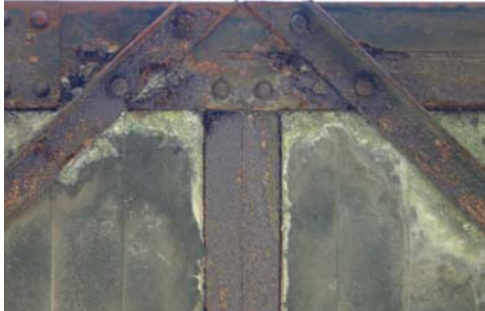
<p>Detail of supporting steel for concrete decking.</p>

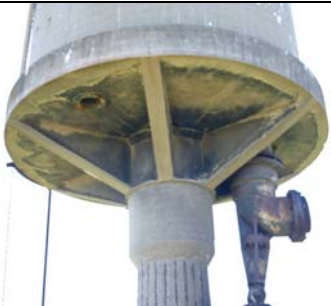
<p>Ribbing on the base of the tank and the spigot for "the bag". It is thought that the column and the tank are separately cast and joined on site.</p>

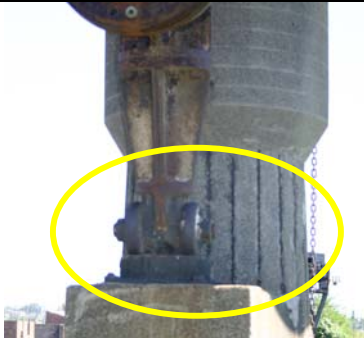
<p>These wheels allow "the bag" to pivot.</p>

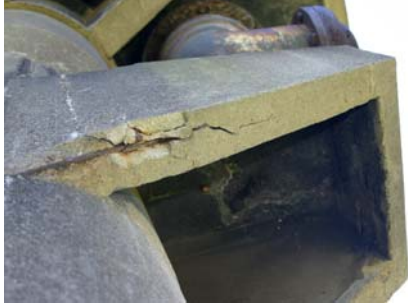
<p>The column and the tank suffer from spalling due to reinforcing steel corrosion.</p>

2) Pillar water tank	State Significance. Recommend removing, stabilising, and re-siting to location within Intermodal Logistics Centre	Technical flaws in construction led to extensive spalling of concrete. Lifting points for tank are lost. Cradle or support structure would be required for lifting and transport.

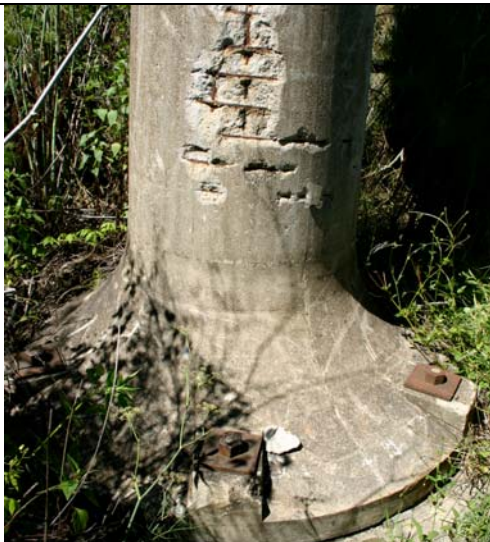
<p>The base of the column is flared and fixed to an aggregate concrete base with steel bolts and washers. Spalling is also evident on the column.</p>

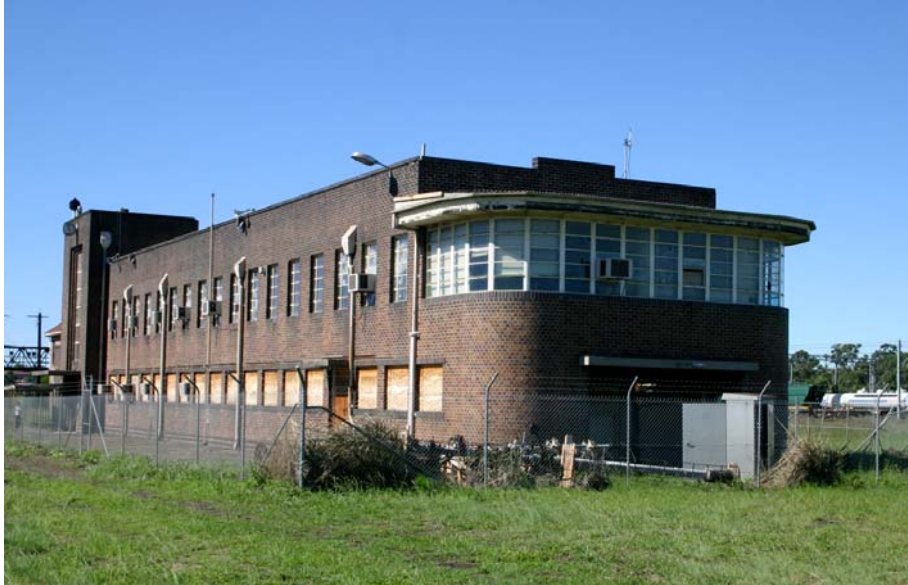
Figure 51. Administration Building at former Enfield Marshalling Yards, Northern elevation. January 2005.

As a masonry building, the administration building does not lend itself to disassembly and relocation. The site is required for the operation of the proposed Intermodal Logistics Centre. Consequently, Graham Brooks and Associates recommend recording the building including a brief history, sketch plans, measurements and photographs, followed by demolition. The recording report for the administration building should be lodged with the Local Studies Collection of the Strathfield Public Library.

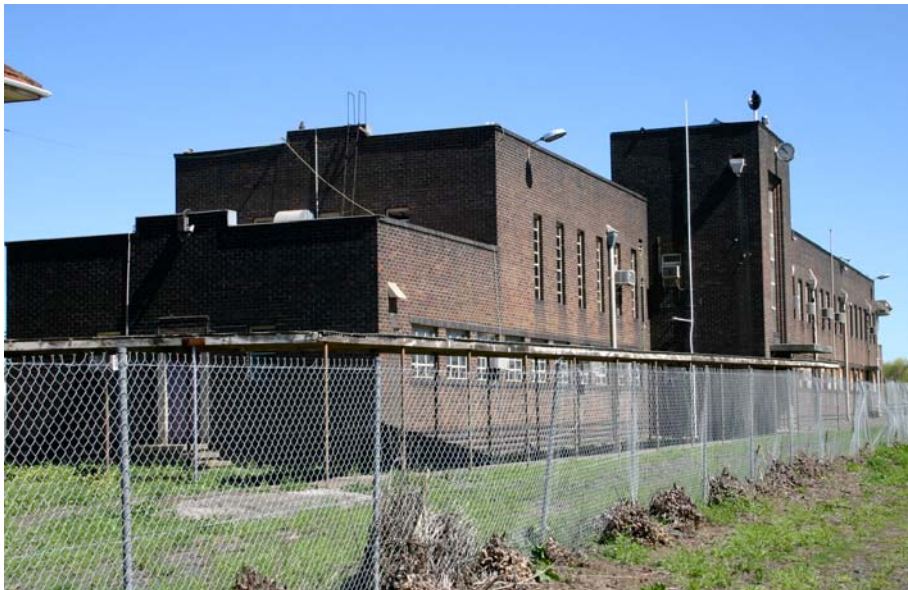
Figure 52. Administration Building, Southern elevation, January 2005

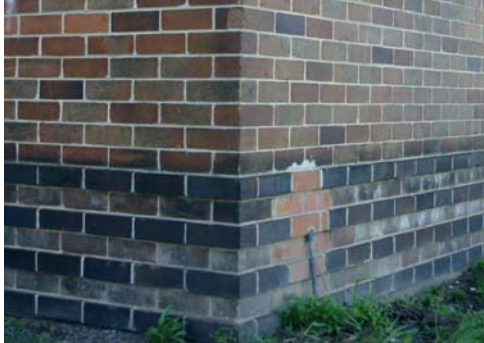
<p>Ornamental brickwork on western elevation. This multicoloured ornamental brickwork surrounds the building to form a visual plinth.</p>

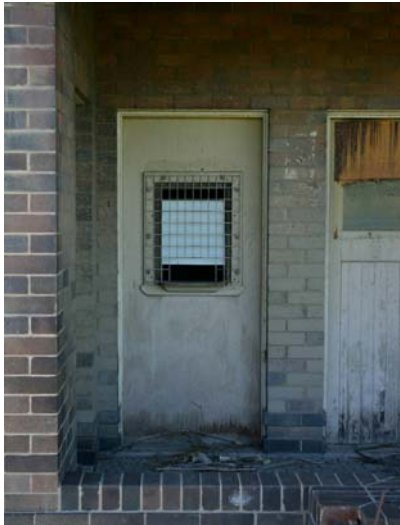
<p>Pay window on the northern elevation of the administration building.</p>

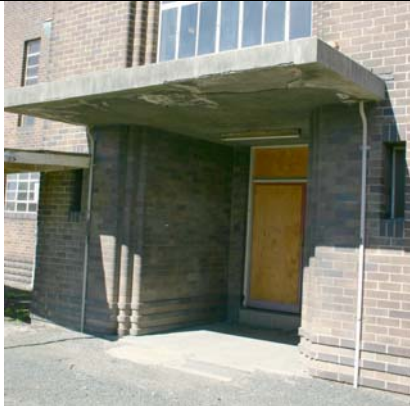
<p>A cantilevered reinforced concrete beam forms a roof over each original entrance. This is the main entrance to the western elevation.</p>

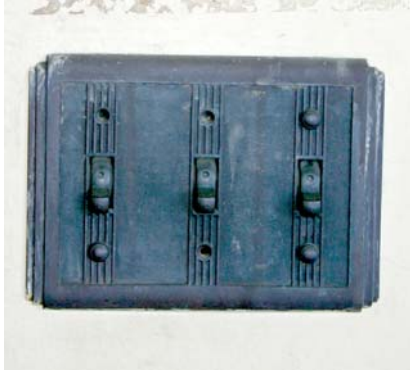
<p>Bakelite three-gang electric light switch. This type of material is available in the late 1940s.</p>

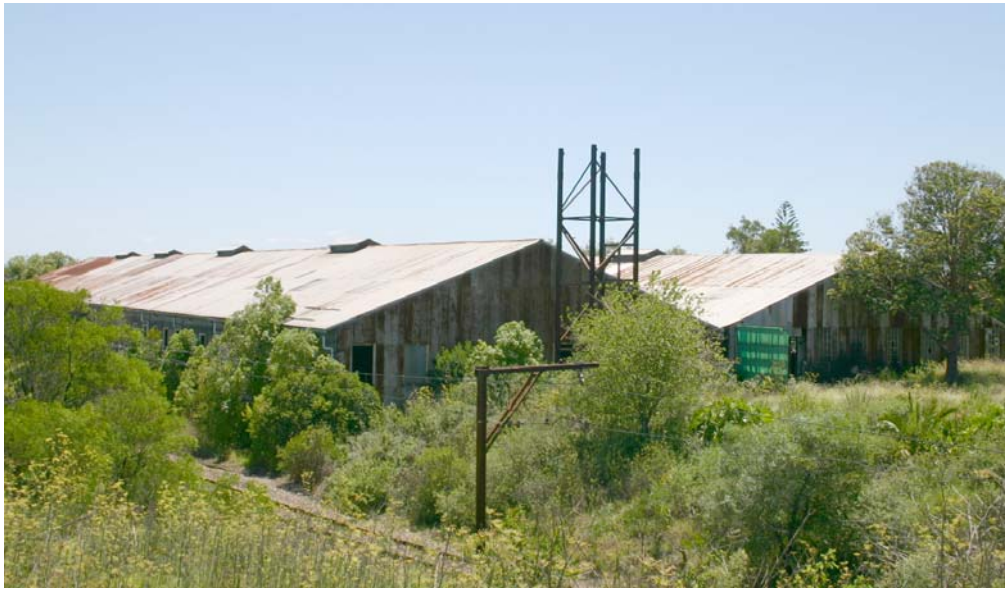
The spans are formed from Howe-type truss and rest on a wall of cast iron columns bridged by wrought iron latticed beams. The east side of the shed is below grade and massive concrete supports have been poured over and around many of the cast iron beams on this side. On the western side, these cast iron columns rest on (not in) concrete footings.

Figure 59. The southern elevation of the Tarpaulin Shed. A tank stand is in the foreground. The tank was removed after 1991. January 2005.

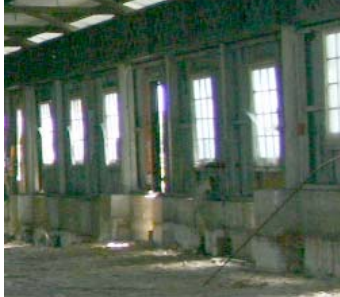
<p>Most cast iron columns on the eastern wall are encased in massive concrete footings.</p>

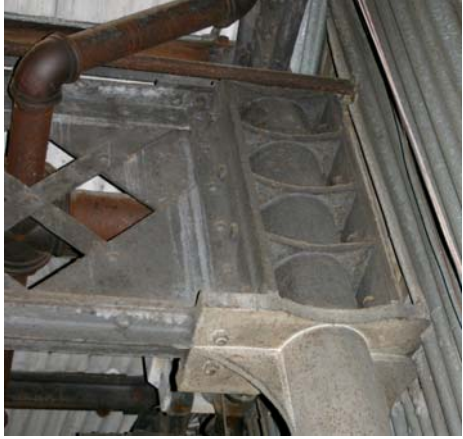
<p>Detail of cast iron column and lattice truss beam assembly.</p>

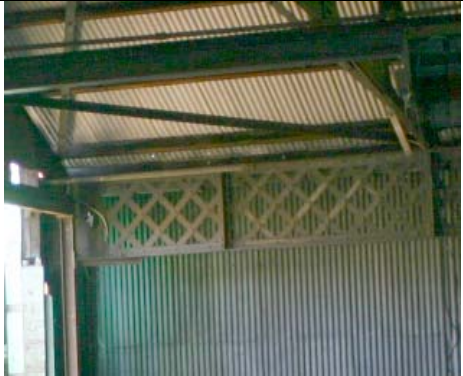
<p>Detail of lattice truss beam. Cast iron columns are used throughout the building.</p>

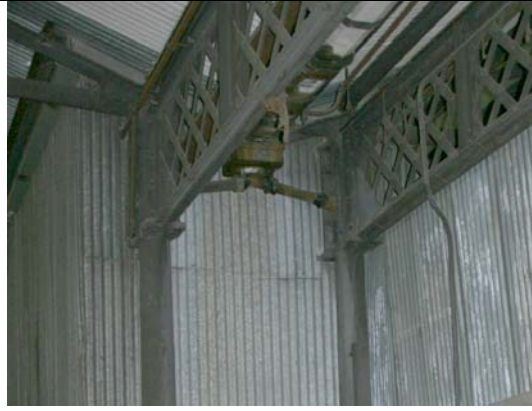
Paired columns in the centre of the building. The box gutter closed the roof gap and rainwater was carried through the gutter to the cast iron column downpipes.

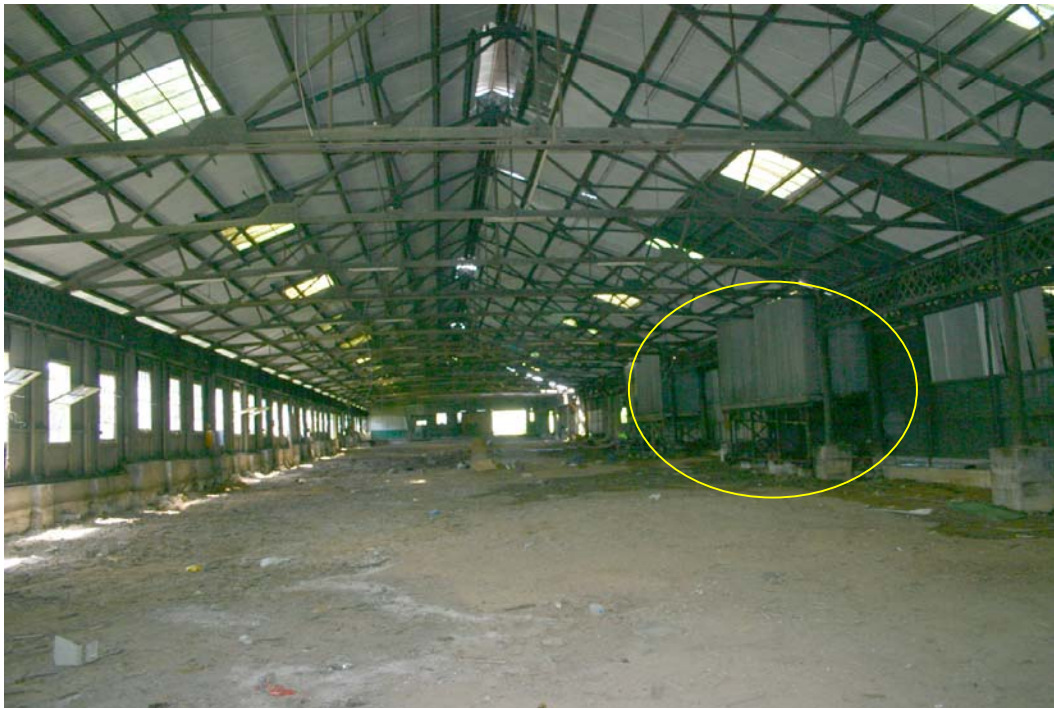
Figure 61. Interior of bay 2 of the Tarpaulin Factory, Columns are arrayed along each wall section. A toilet and shower complex (yellow) is set into the centre of the building. January 2005

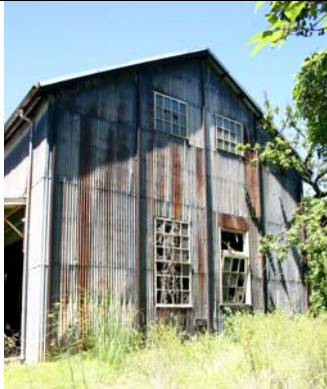
<p>Waxing Room, former Enfield Marshalling Yards</p>

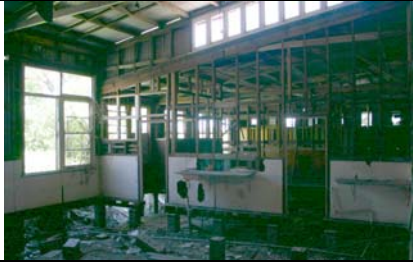
<p>Detail of women's room</p>

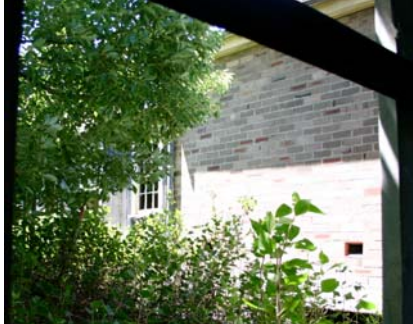
<p>Detail of Men's room, locker and showers</p>

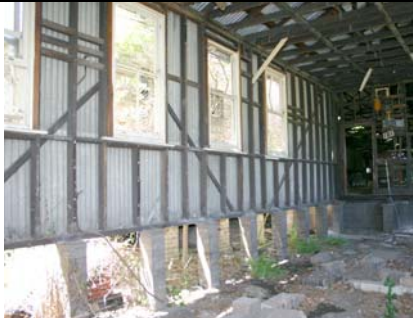
<p>Detail of meal room</p>

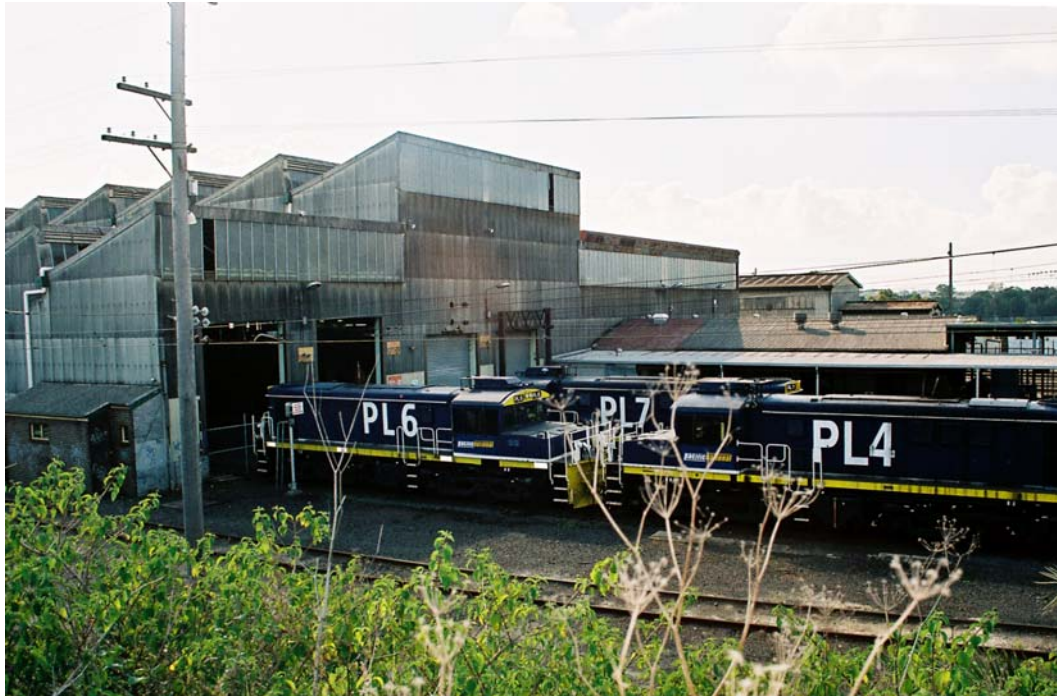
Figure 65. The DELEC Service Centre Workshop from the southern aspect.

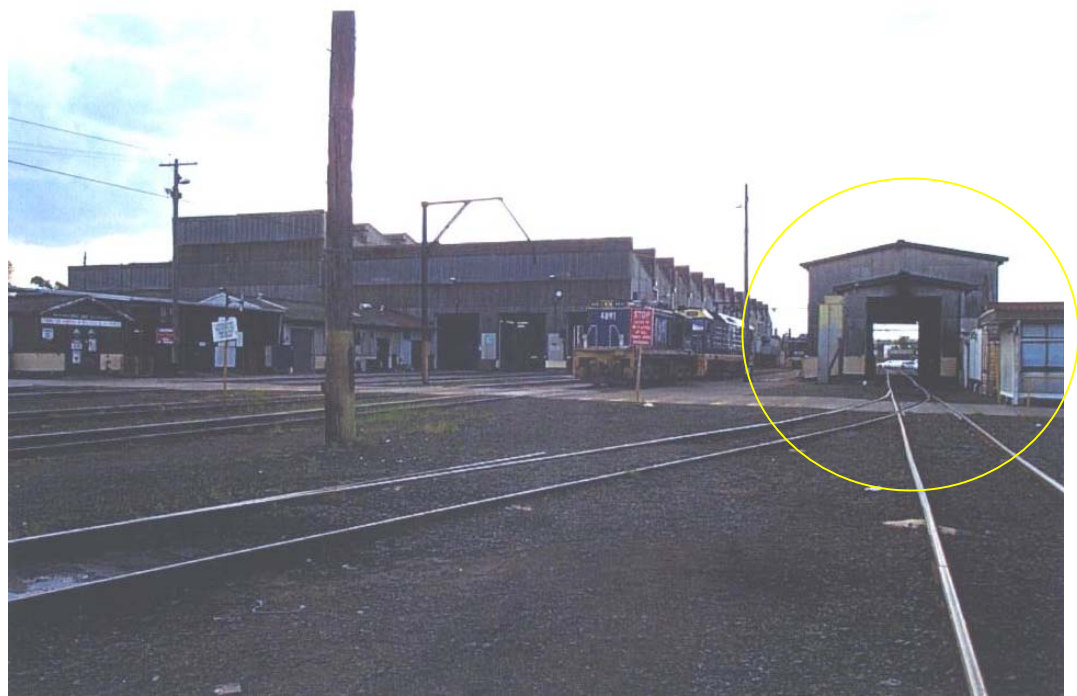
Figure 66. The DELEC Workshop (left) and the wheel lathe building (right, circled). Otto Cserhalmi and Partners, Part of the Former Enfield Yard. Heritage Assessment, 2002.

The wheel lathe device, for example, has been replaced and updated throughout its lifespan. The original 1961 wheel lathe has been discarded.
