Intermodal Logistics Centre at Enfield Environmental Assessment

CHAPTER 15

HERITAGE

■ October 2005

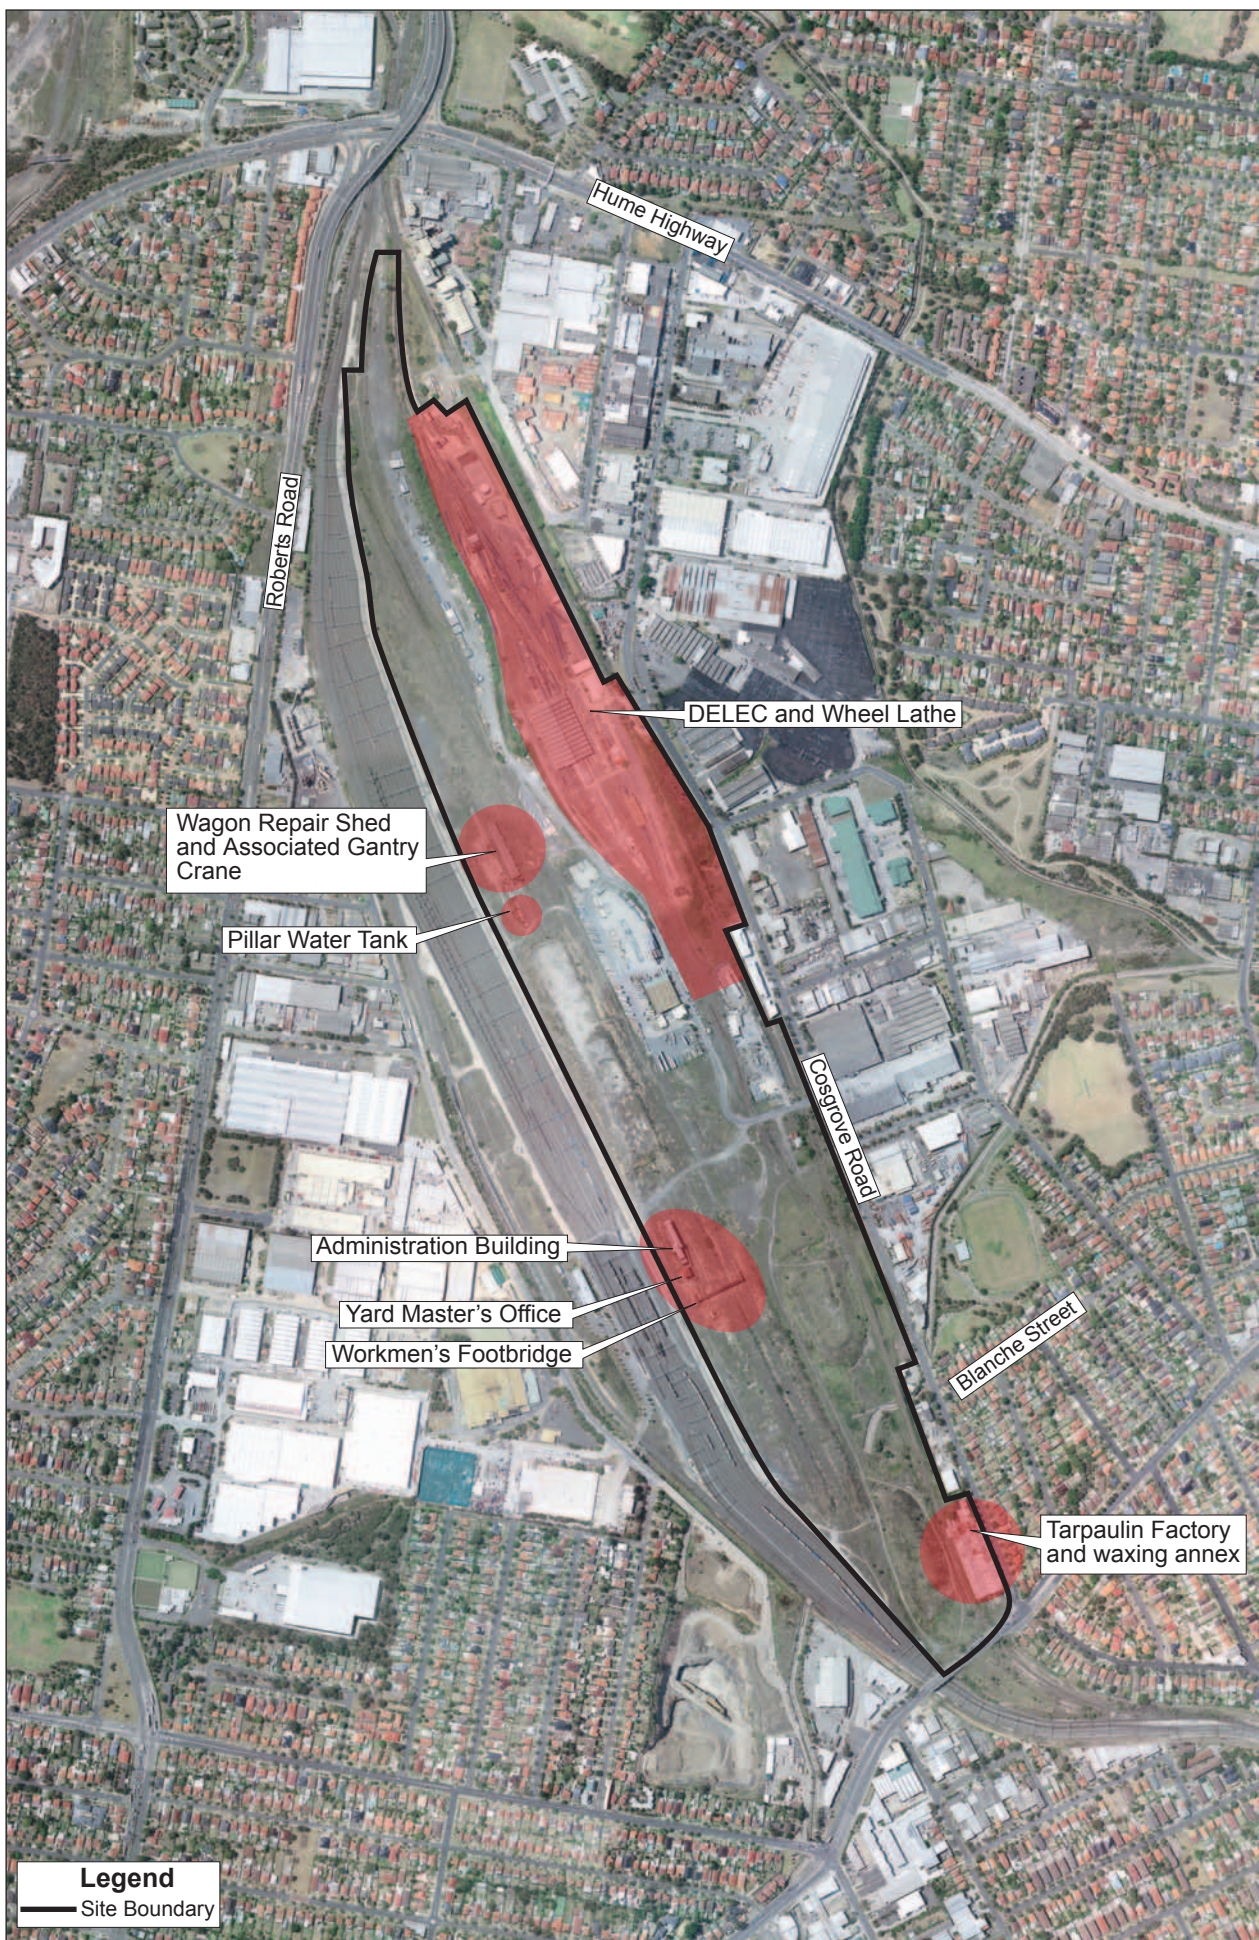
This section provides a description of items and elements remaining on site, with an assessment in terms of their heritage significance. The former Enfield Marshalling Yard landscape has also been assessed for its heritage significance. **Table 15-2** lists the items assessed as part of the European heritage assessment and their status in terms of local and state heritage policies and/or registers. The location of these items is shown in **Figure 15-1**.

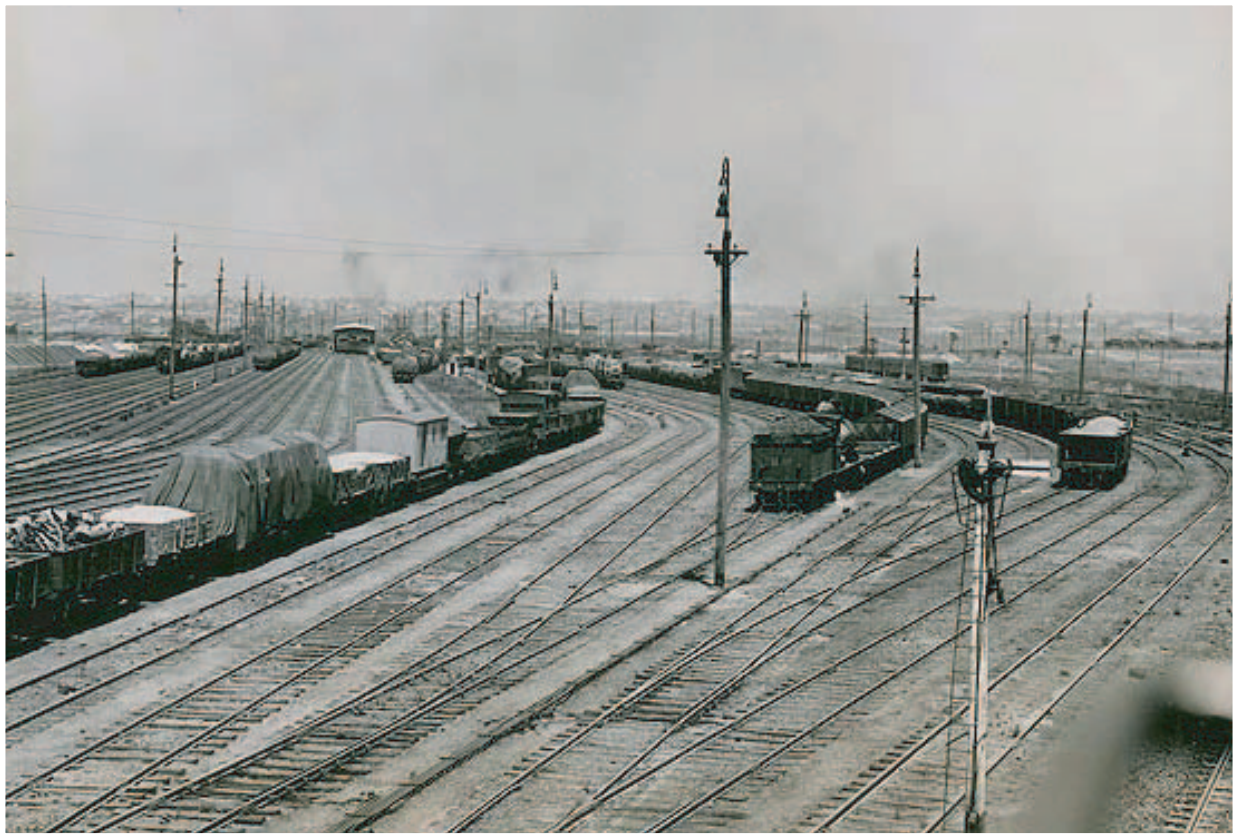
Figure 15-2
 Former Enfield Marshalling Yard from the
 South East when it was in Operation

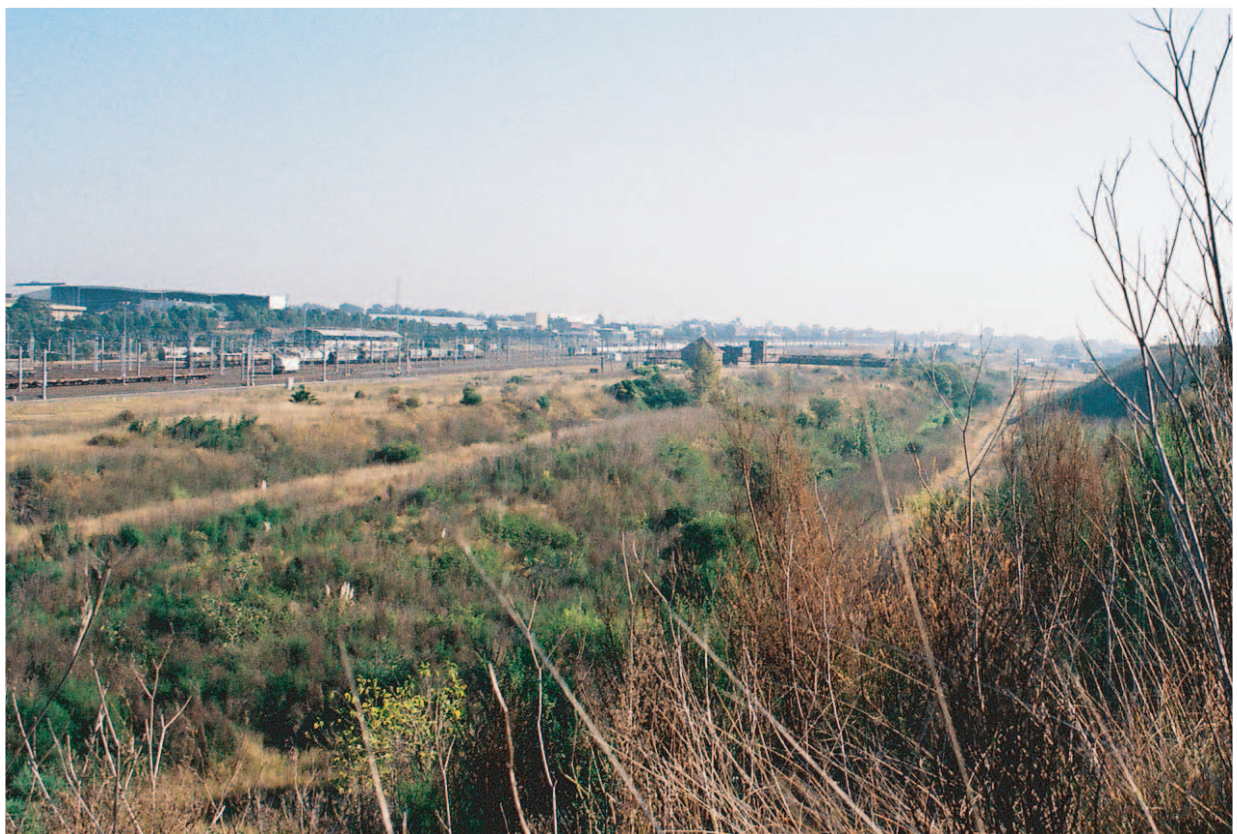
Figure 15-3
 Former Enfield Marshalling Yard from
 the South East (June 2005)

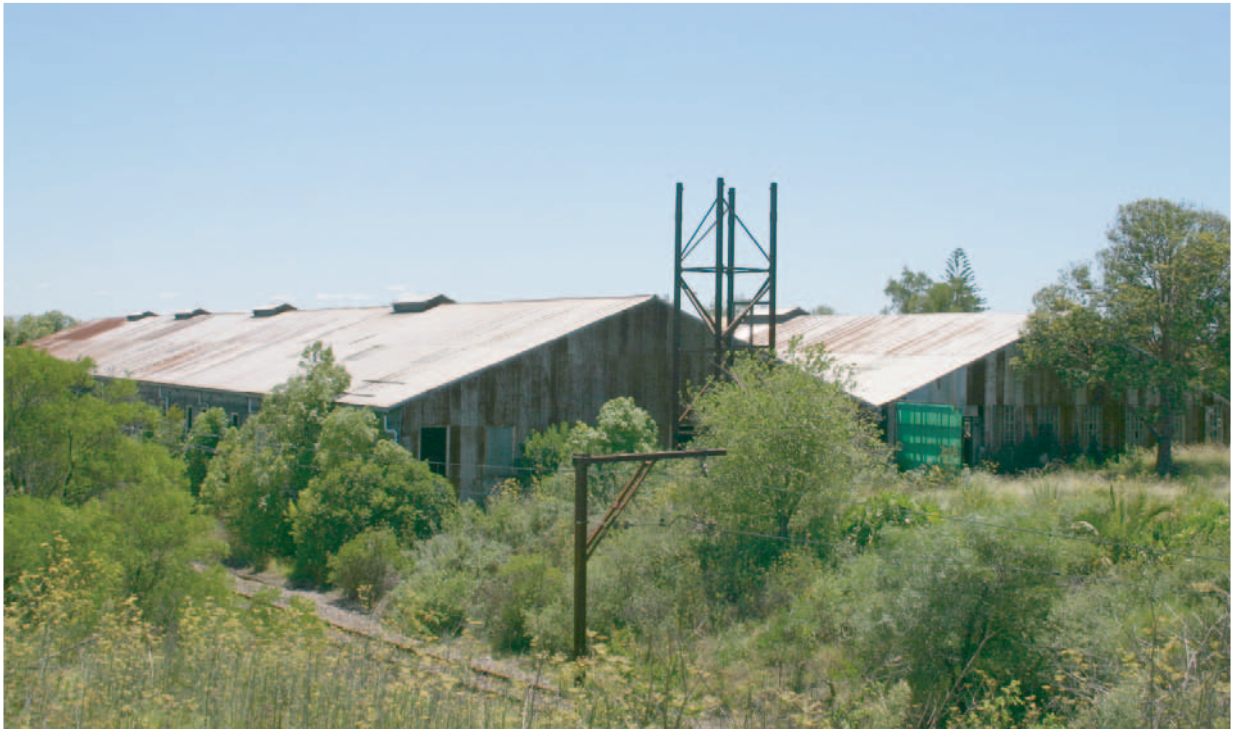
The Enfield ‘Tarpaulin Factory’ is considered to be an assemblage of two 19th century prefabricated cast and wrought iron single bay buildings that were once in the Sydney Yard (now Central Station). The structure was reassembled as two bays to form a Tarpaulin Factory in the former Enfield Marshalling Yards as shown in **Figure 15-4**. Tarpaulins made in this shed had a variety of uses including cover for the loaded wagons, tool covers, leggings and other railway-related items. The inner spans are of considerable width and would have allowed for the workers to lay out the cloth for cutting, sewing and insertion of grommets and attaching ropes. The spans are formed from Howe-type trusses and rest on a wall of cast iron columns bridged by wrought iron latticed beams. The fabricated cast iron columns were supplied by Pope Maher and German, Darlington Ironworks.

The Tarpaulin Factory also includes a combination of structures to the north of the iron building. The annex to the Tarpaulin Factory, called the waxing room annex, was the area where wax was melted for application to the cloth, an operation that would have been hazardous and very susceptible to fire. This element was moved from the Sydney Yard where in 1920 it served as a ‘Fireproof Tarpaulin Store’. The Tarpaulin Factory operated from 1925 until 1991 when the staff had dwindled to 15 from the wartime high of 81 employees. Since closure the factory has been subject to vandalism. Although most elements of the operation, such as timber flooring, equipment and tarpaulins have been lost, the history of site operations has been well documented (Godden Mackay, 1991). The study preserves the factory methods of working, images, canvas patterns and an interview with a life-long employee of the factory. The Tarpaulin Factory was a unique operation amongst the NSW Government Railways infrastructure. The annex has some heritage significance through its association with the factory but low significance without this association.

Figure 15-4
Tarpaulin Factory

As the Tarpaulin Factory is to be retained in its current location it would be stabilised to prevent further deterioration while determining the options for future use. The Pedestrian Footbridge and Pillar Water Tank would be dismantled and repaired by a suitably qualified specialist. Items, which could not be relocated immediately, would be stored in an appropriate manner to ensure no damage occurs during the construction stage. These items would be relocated once construction is complete. If during detailed design it is clear that retention of these items on site is incompatible with the ILC design, they could be offered to an external rail heritage organisation.

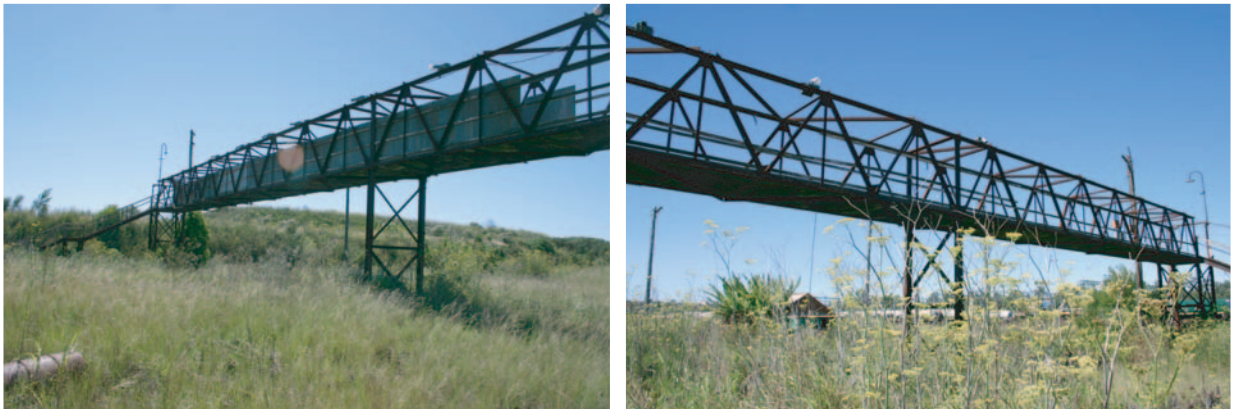
The Pedestrian Footbridge was constructed in 1937 to replace a previous footbridge. It is a steel Warren Truss structure with a reinforced concrete deck resting on two sets of braced pylons. It is currently in poor condition with significant corrosion evident at the joins and concrete spalling. Earlier reports suggest that the footbridge was originally 120m long and has since been reduced to 80m. **Figure 15-5** shows its current form.

The height of the footbridge is considered an important feature as it is tall enough to have cross-bracing above the deck. A survey of railway footbridges conducted by Don Fraser in 1996 noted that while there are 248 footbridges on the rail network, only three are ‘through’ Warren Truss types such as this. This places the Enfield footbridge into the ‘rare’ group.

Figure 15-5
Pedestrian Footbridge

- **Pillar Water Tank** – the lifting points on the tank are lost. A cradle and support structure would be required for lifting and transport. Relocation options to consider situating in areas where the item would be visible to an audience, including options on the entrance roundabout;

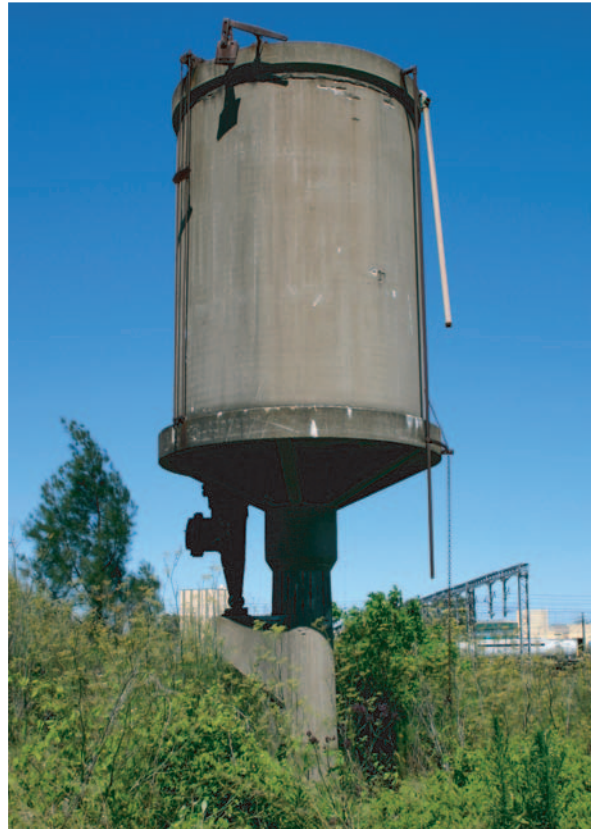
The Pillar Water Tank appeared on the proposed ILC site in 1918 to provide a watering station for steam powered locomotives. It comprises a cylindrical concrete tank and various concrete mouldings, mounted on top of a reinforced concrete pillar. A swivelling jib completed the assembly. The dimensions of water tanks were typically nine feet in diameter, 28 feet high with capacity to hold 4,000 gallons of water. Research undertaken by Ray Love has identified that this is the only concrete pillar tank surviving from the NSW Government Railway system.

The water is fed through the column of the tank and extracted via ‘the bag’, a canvas tube fixed to the tank to carry the water to the locomotive. The bag is now missing. The tank has a PVC overflow device attached, indicating that it continued to be used after the 1973 disappearance of steam power from the network. **Figure 15-6** shows the Pillar Water Tank in its current form. The column, tank and base suffer from spalling due to corrosion of the reinforced steel.

Very little is known about the design and origin of this form of tank within the railway system. It displays particular engineering significance as an early 1900s design using moulds, steel reinforcing mesh and a modular design assembled on site. The Pillar Water Tank is not listed on any statutory heritage registers, although it was assessed as part of the Tropman and Tropman report (1999). As a sole representative of the unique concrete form, the tank was considered by the heritage assessment to be of State significance.

Figure 15-6
Pillar Water Tank

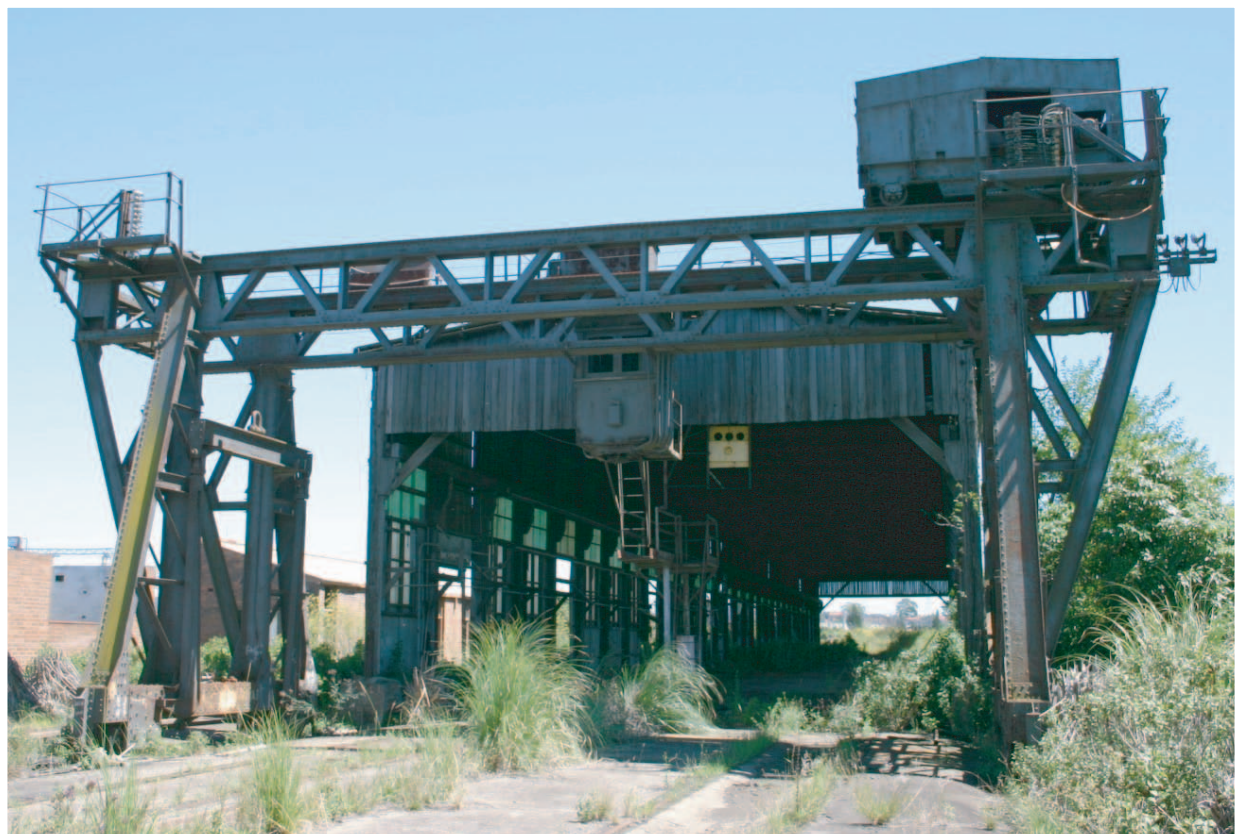
The Wagon Repair Shed is a braced frame construction comprising horizontal timbers bolted to hardwood posts that extend for the full height of the frame. The east side of the building is open, the west side enclosed and the roof enclosed with fibrous cement corrugated sheeting. A group of brick buildings, now in ruins, lies to the south west of the shed and may have supplied administrative support and specialised trades for the later workshop activities, most likely these buildings were added on later. An electric-powered gantry crane was also added at a later date. This is shown in **Figure 15-7**.

A building inspection conducted in 2001 identified significant termite damage in 25 of the 62 timber supports. The building is not technically innovative and the structure has been stripped of devices used within the building. In its current setting the building has diminished ability to communicate its significance due to the limited access to the site, its condition, loss of original tools, equipment and context. As a consequence, the heritage significance of the structure is considered as part of the heritage assessment to be of marginal local significance. The external gantry crane is a commonplace sight in supply yards, coastal wharfs and transshipment points throughout the Sydney region. As such the crane is considered to have low heritage significance as a singular object and has only local significance through its association with the Wagon Repair Shed.

Figure 15-7
Wagon Repair Shed and Associated Gantry Crane

- **Wagon Repair Shed and Associated Gantry Crane** – the item should be dismantled and salvageable structures of significance should be removed and used where possible on the site, or offered to an external heritage organisation. There is an opportunity to reuse the wooden planks from the roof on site to create amenities such as picnic tables and benches;

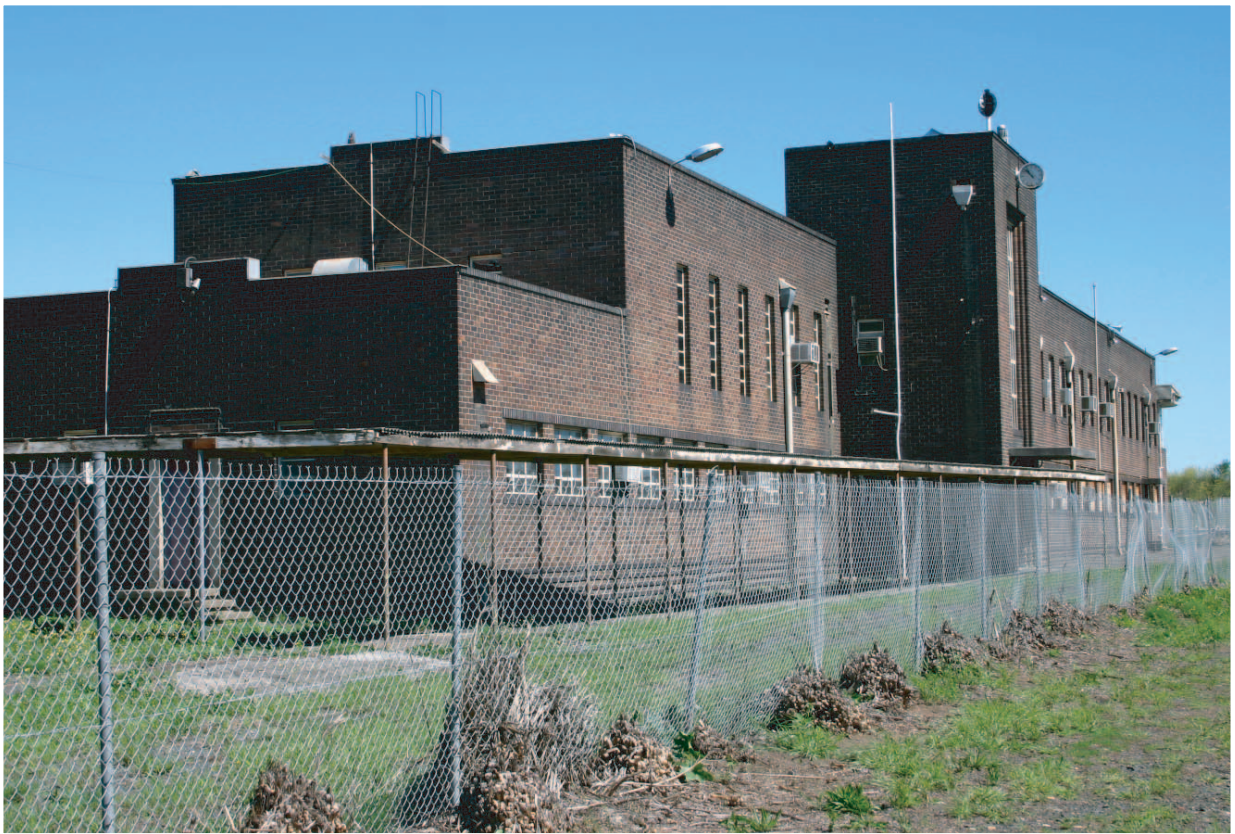
This building was designed in 1945 and constructed soon after. Shown in **Figure 15-8**, the building was designed to provide offices for railway administration and consists of two levels of office accommodation, toilets, staff canteen area and a panoramic office to the northern end of the building on the upper level. The building is formed of multicoloured bricks and metal casement windows. Undocumented former employee interviews suggest that the Administration Building replaced the Yard Master's Office as the centre for the Enfield Marshalling Yards. The Administration Building is designed in a 20th century modernist style influenced by the Dutch architect William Dudok (1884-1974). This style was very popular in Australia, with many examples of this form of architecture in Sydney. Air conditioning has been retro-fitted onto the building and since the closure of the yards, the building has been subject to some vandalism.

Figure 15-8
Administration Building

- **Administration Building** – although this item is considered to be of no heritage significance photographic records and a report should be prepared prior to demolition;

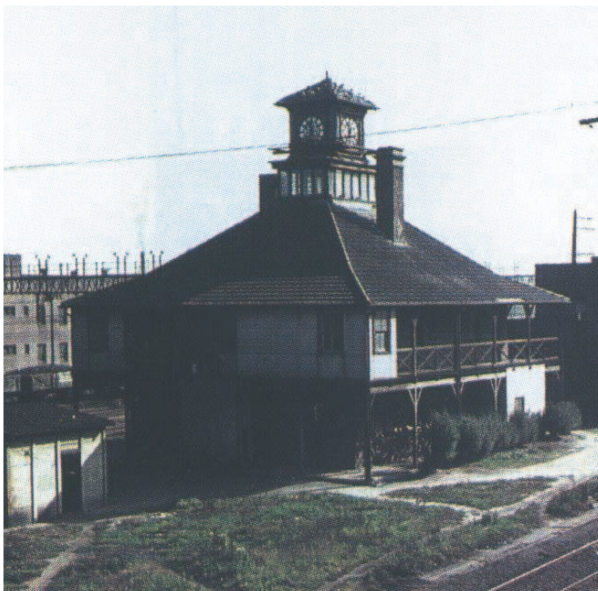
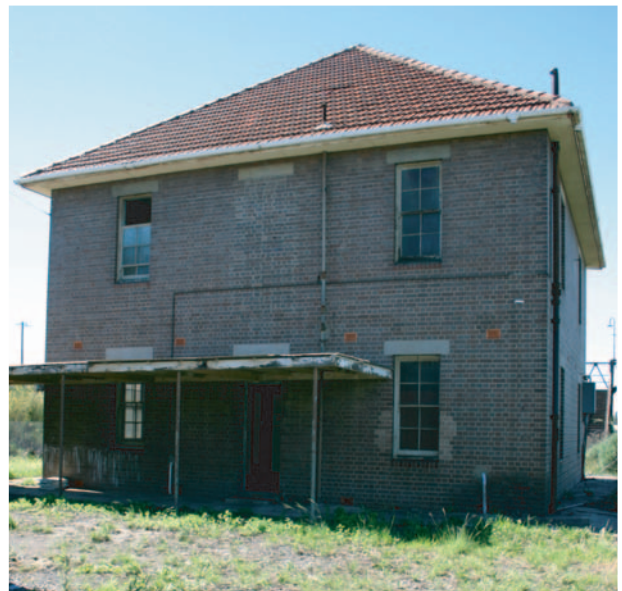
The Yard Master's Office is a two-storey brick building with a gabled fibrous cement tile roof. There are four rooms on each floor with a fireplace in each. The original plan has been altered since its construction. Plans of the building show the rooms to be occupied by different personnel including the timekeeper, shunters, foreman, guard, clerk and Yard Master and assistant.

The structure was fitted with a rooftop observation platform some time before 1967 that was reached via a surviving internal timber staircase. The observation platform, the clock, chimneypieces, mantels and surrounds were removed in the late 20th century. The building was radically altered by these changes, as well as by re-roofing with tiles.

The Yard Master's Office was also surrounded by a partially enclosed verandah and balcony at each level. This has since been removed and a number of the windows and verandah doors have been bricked in and new doorways fashioned in the interiors. The change to the Yard Master's office is shown in **Figure 15-9**.

Figure 15-9
Yard Master's Office in 1964 and 2005

- **Yard Master's Office** – this item has been subject to significant fabric losses which have diminished its heritage value. There are no opportunities for adaptive reuse within the proposed ILC, therefore photographic records and a report should be prepared and the building demolished; and
