OPERATION OF BULK LIQUIDS Berth No.2 Port Botany

INDEPENDENT ENVIRONMENTAL AUDIT REPORT

FOR THE OPERATION OF BULK LIQUIDS BERTH No 2

4 and 5 December 2017

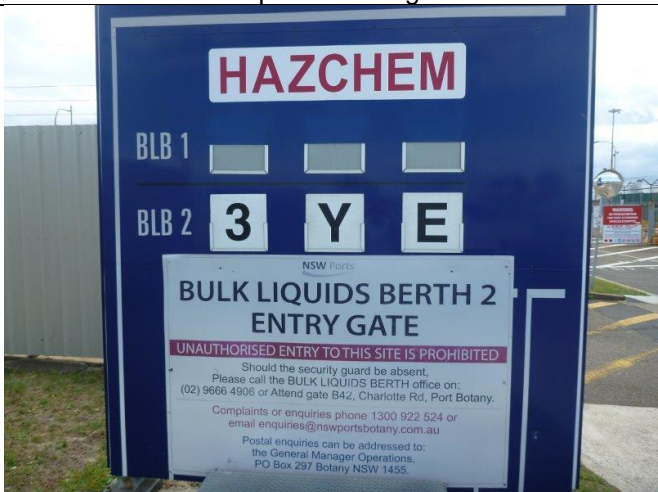
Photo: 3: Entry to site – Signage as required by the Conditions of Approval, security measures and emergency information. However email address needs to be updated.

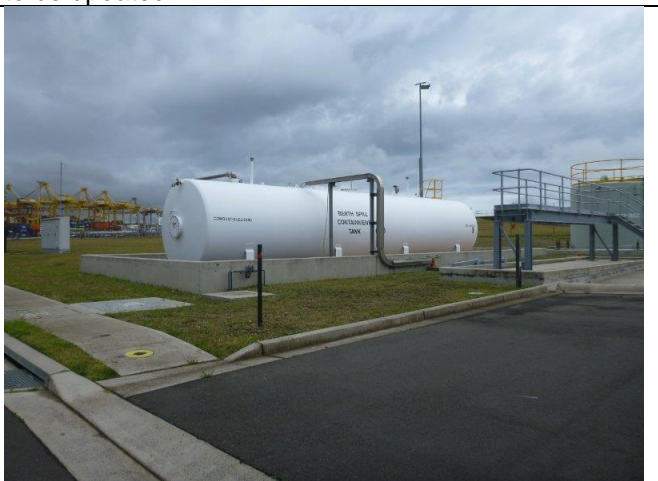
Photo: 5: Berth spill containment tank (empty) – fully bunded. Would be used in case of spill at the berth and on site

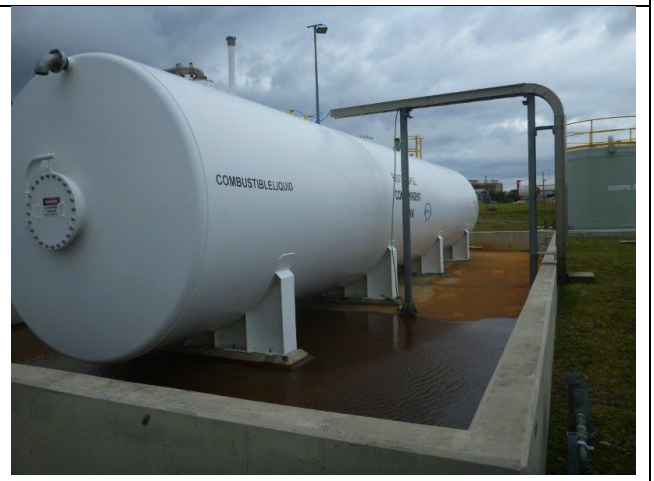
Photo: 6: View showing spill containment tank with bund.

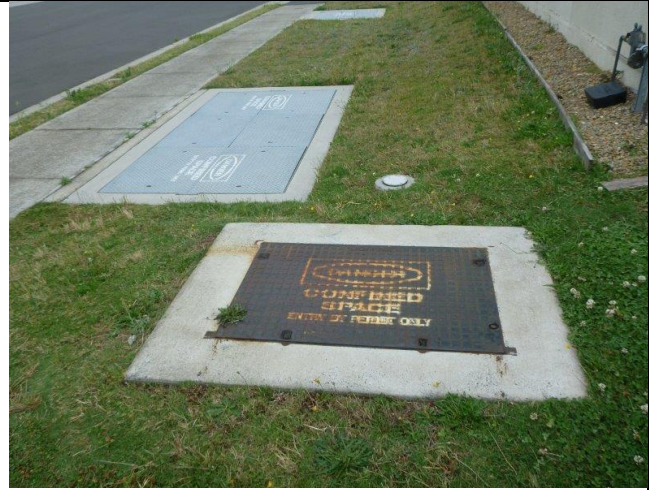
Photo: 8: Gross Pollutant trap and oil water separators installed underground. Cleaned out in 2016.

- Minimal waste is generated on site. Small quantities of waste are generated in the site offices and is removed by approved waste contractors (Remondis). Records are retained
- The gross pollutant trap (GPT) and Oil/Water separator were cleaned out and waste was removed and appropriately disposed of by an authorised contractor
- Quarantine waste bins located at the BLB2 offices were not fully closed at the time of the site inspection, and it was considered that waste could escape from the bins. **Refer to OBS #3**
- Minimal litter was observed on the site

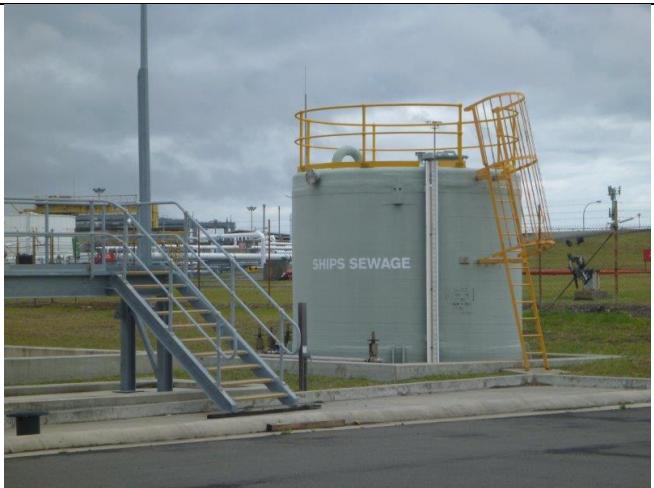
Photo: 9: Sewage tank installed to accept ships sewage. The tank has not been used to date and remains empty.

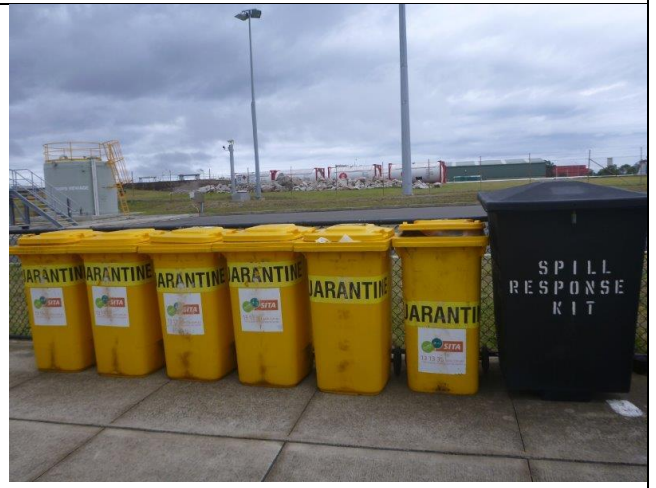
Photo: 10: View of quarantine bins and spill response kit stored near the BLB2 control room. Yellow bin on the right could not be closed due to overfilling by ship operators (informed during audit)

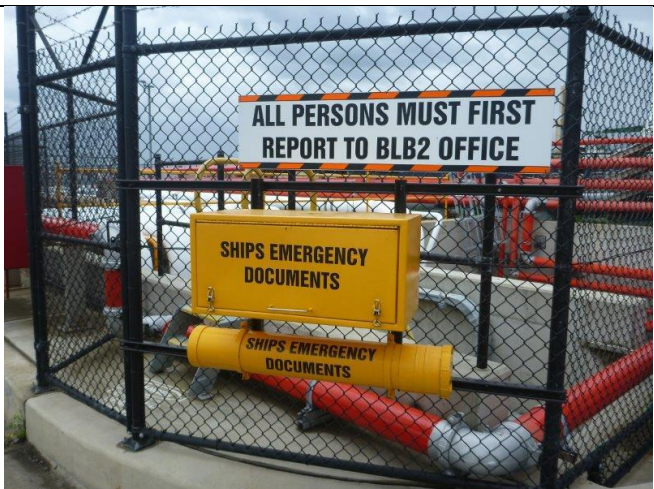
Photo: 11: Ships Emergency documents stored in the box or tube during transfer operations (sighted)

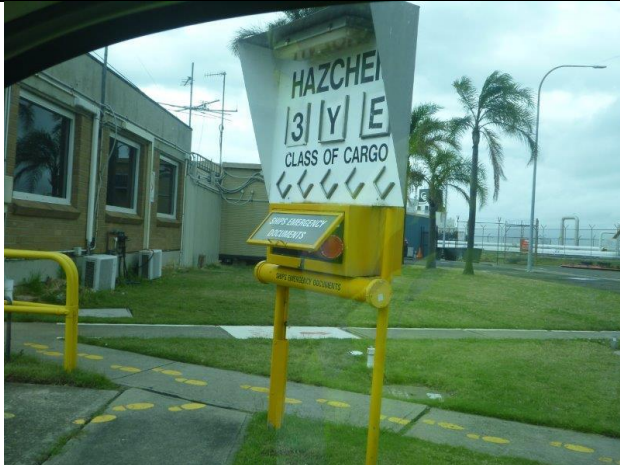
Signage indicating the class of cargo / liquid being transferred at the time of the audit. Provides emergency responders with information on response requirements

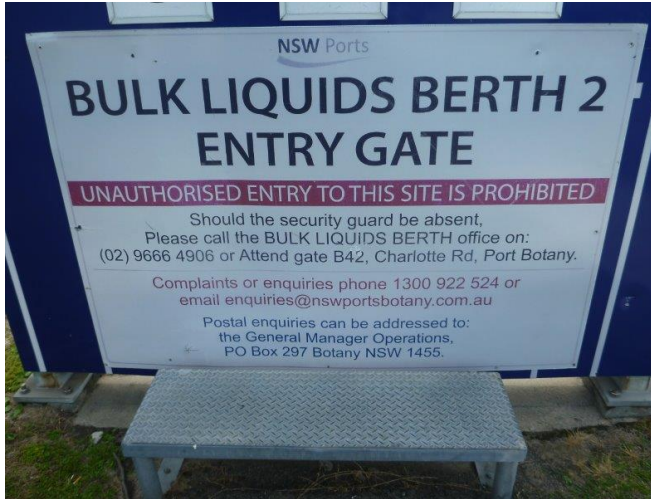
5.2	NSW Ports	<p>Prior to the commencement of construction of the project, the Proponent shall ensure that the following are available for community complaints for the life of the project (including construction and operation):</p> <ol style="list-style-type: none"> A telephone number on which complaints about construction and operational activities at the site may be registered; A postal address to which written complaints may be sent; and And email address to which electronic complaints may be transmitted. <p>The telephone number, the postal address and the email address shall be displayed on a sign near the entrance to the site, in a position that is clearly visible to the public, and which clearly indicates the purposes of the sign.</p>	<p>Signage with the required information is displayed at the entrance to the facility, however it is noted that the email address on the sign and in the OEMP are not the current correct email address. The current correct email address is enquiries@nswports.com.au. See photo below</p>

<p>A test on the email was conducted during the audit, and it was found that the email was forwarded to the correct address and was received and responded to.</p>		OBS #2
